GCCA+SUPA - BANABA TRIP REPORT

13th January 2022

Trip Name	Banaba Trip for the Survey of the Existing RO Storage Shed (Formerly known as the Cargo Shed)		
Participants' name including team leader	Teuea Tebau SUPA National Coordinator leading the team Kaiea Collins – MISE structural engineer Auaio Enota – MISE Cost Estimator Tokiiia T – MISE Builder		
Trip sponsor	GCCA+SUPA		
Start date	06/01/2022	End date	10/01/2022
Prepared by	Teuea Tebau (compilation) with specific part contribution from the following: Kaiea on specific engineering parts Auaio and Tokiiia on specific construction and estimating parts

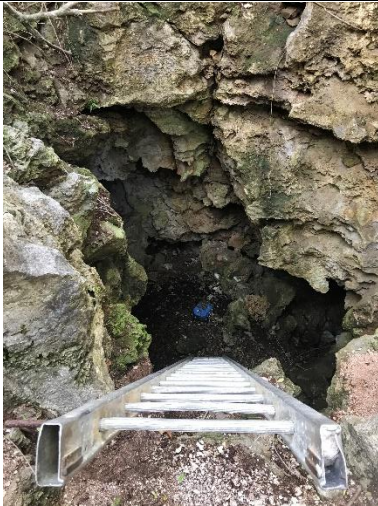
Fig A01 – Entry to the cave

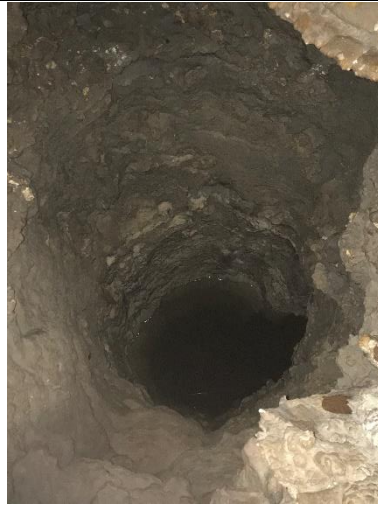
Fig A02 – Well within the cave

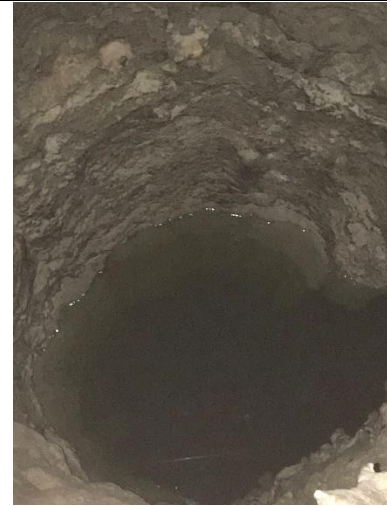
Fig A03 – zoomed in reserved Potable Water source within the cave

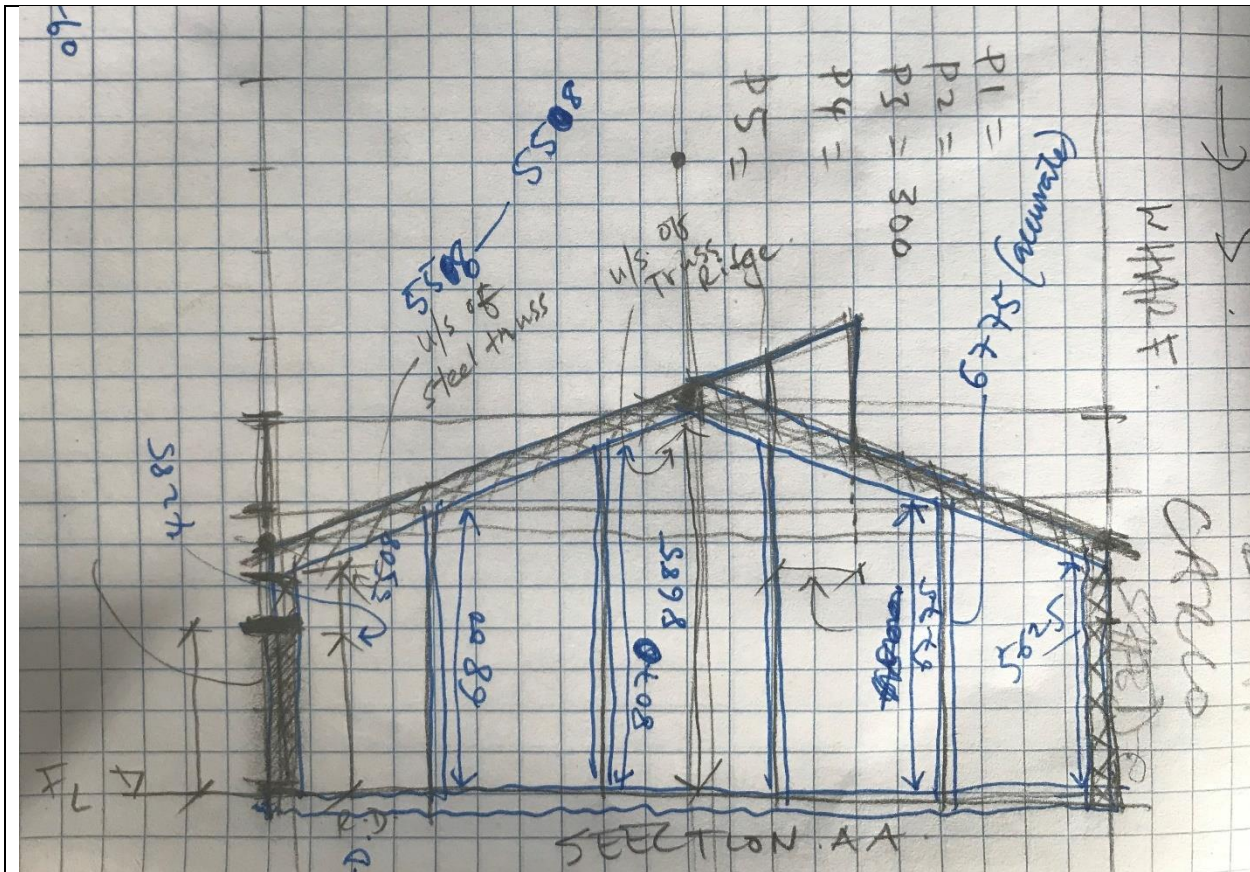
Fig A08 – Cross section sketch showing heights measurements.

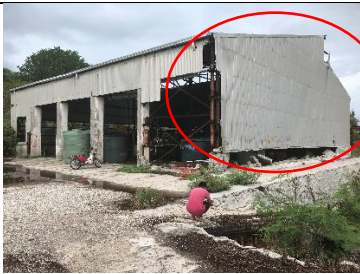
No.	Issue	Solution	Location/site
1	The existing RO shed roof to wall framing structures deemed to be unsafe and require immediate demolition. Except the floor slab as inspected by the engineer and confirmed to be in really good shape and condition and can be retained for future use.	Demolish the roof to wall framing structures. Retain the foundation and floor slab for the new construction to reuse.	Near the harbor slightly toward the north west, on higher ground. Full detailed descriptions in the Engineer's report attached as Annex 1.

Fig A09 – leaning wall on the brink of collapsing.

- Cautious dismantling (demolition) of the deteriorated structures to avoid injuries or worst. These include the whole roof structures to the wall framing and rest of supports etc. Also completely remove any steel and rusty metal pieces/remains from the retained concrete slab.
- Retain the existing concrete floor slab for reuse with the new proposed building (RO new storage shed as per the approved design). This analysis is detailed in the engineer's recommendations attached with this report.
- Immediate action to the critical civil infrastructure works
- Follow the suggestions of the builder to amend the design to raise the floor slabs by one course (new building only refer to the sketch layout at Annex 3).
- Adjust the design, costing, workplan and other necessary building construction documents based on the findings onsite.

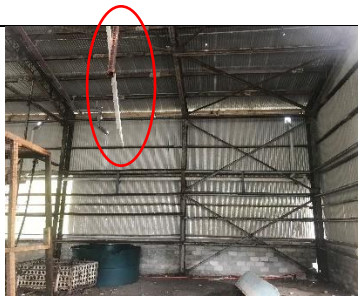
Fig A10 – Hanging sharp steel structures ready to fall anytime.

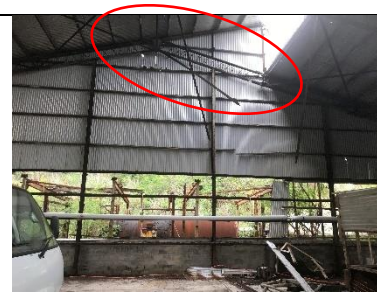
Fig A11 – snapped and disconnected steel ready to fall anytime.

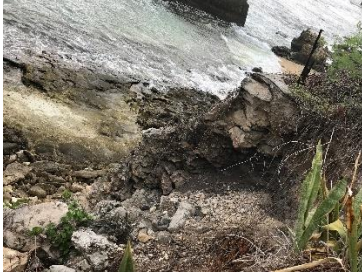
Fig A12 – view down the collapsed seawall 12m in length, roughly slightly more than 10m deep to the beach level. The collapse causes (what appears to be a) landslide.

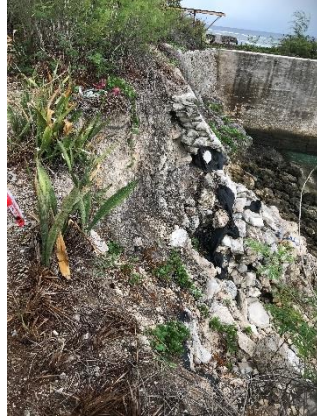
Fig A13 – view from the side at the top, same collapsed seawall.

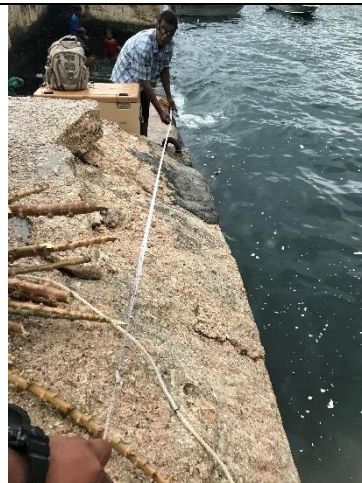
Fig A15 – Jetty concrete steps structure 'chipped' at the edge. Damage measured length is 3.6m and 1m depth at an angle.

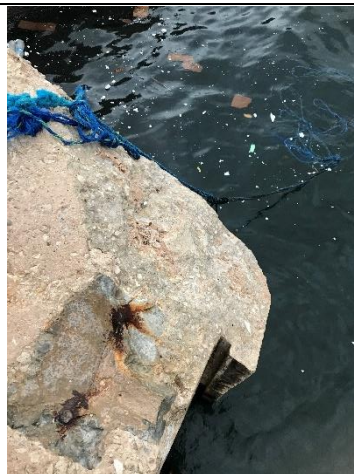
Fig A16 – Another jetty concrete structure 'chipped' at the end, one of the top corners. Damage measured length is 1.3m and 1m deep with 1.1m width.
