Soasoa Integrated Watershed Management Plan

Historic Flood Report

February 2021

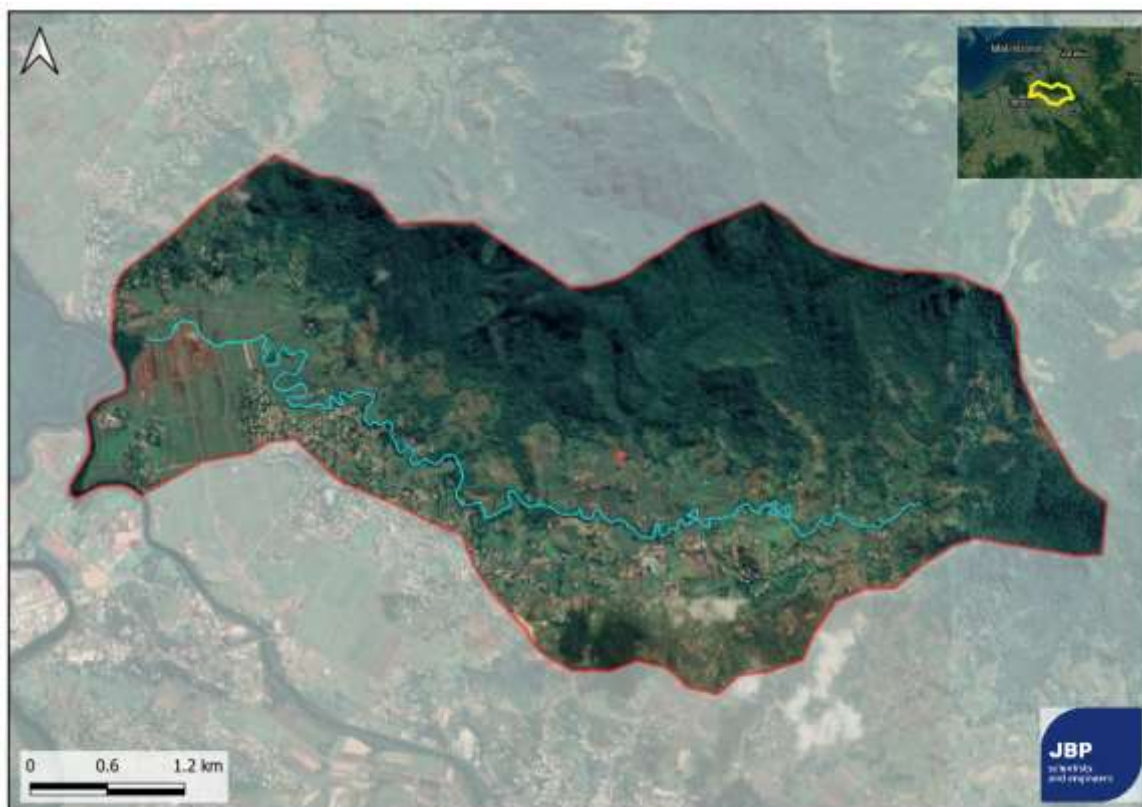
Figure 2-1: Study area

The Soasoa catchment is located within the Macuata Province, on the northern coastline of Vanua Levu. The catchment forms part of a major three-river estuary system, which includes the Labasa, Qawa and Wailevu rivers, which converge and discharge into the ocean. It has a relatively small catchment area, around 20km², with steep upper regions (see Figure 2-1). The steep upper catchments include some of the highest mountains on the island, and face into the common north-westerly cyclone direction. This topography creates exceptional orographic rainfalls, which are rapidly converted into runoff (Terry & Raj 1999)². During flood conditions extreme runoff can merge within the lower catchment, which has flat alluvial terraces and wider floodplains.

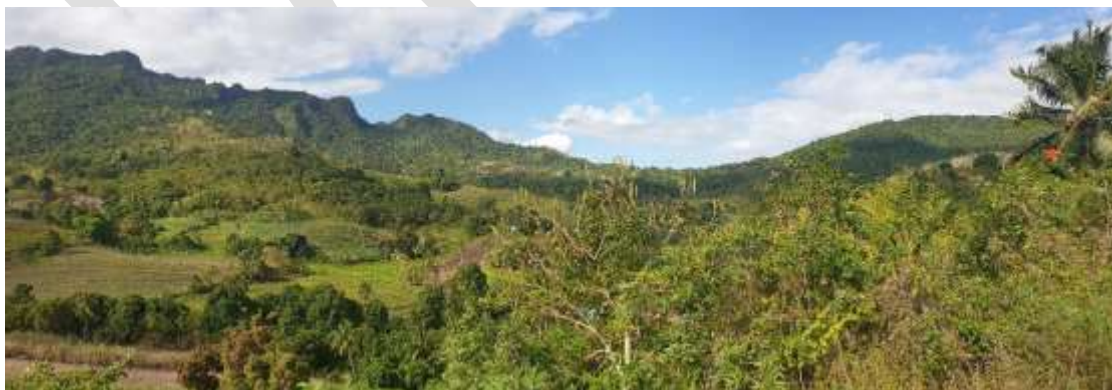
Figure 2-3: Upper Soasoa catchment (Source: Patrick Fong 2020)

Rapid site inspections were undertaken in October 2020 to review catchment conditions. Site images are shown in Figure 2-3 to Figure 2-5. These inspections identified the flood levee and gate structures in the lower catchment to be important for flood mapping. Detailed structure information has been requested for use in this project, however, this information is not available at the time of this report. Should this information be made available it is recommended to be incorporated into the flood model.

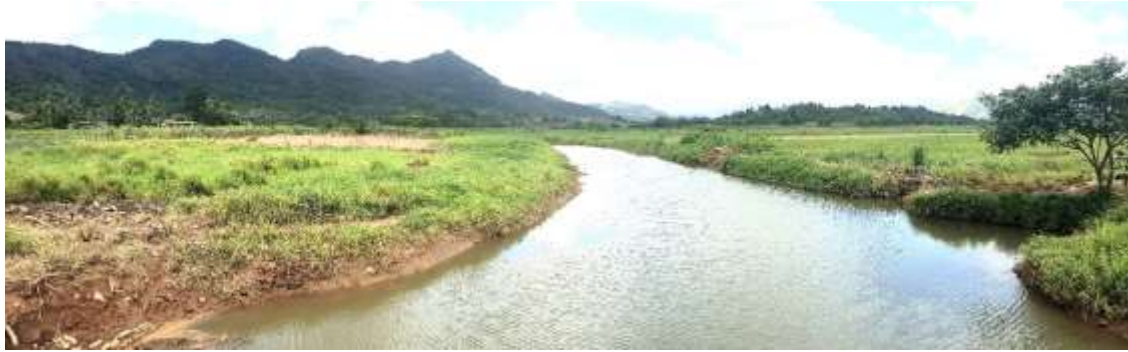
Figure 2-4: Lower Soasoa catchment (Source: Patrick Fong 2020)

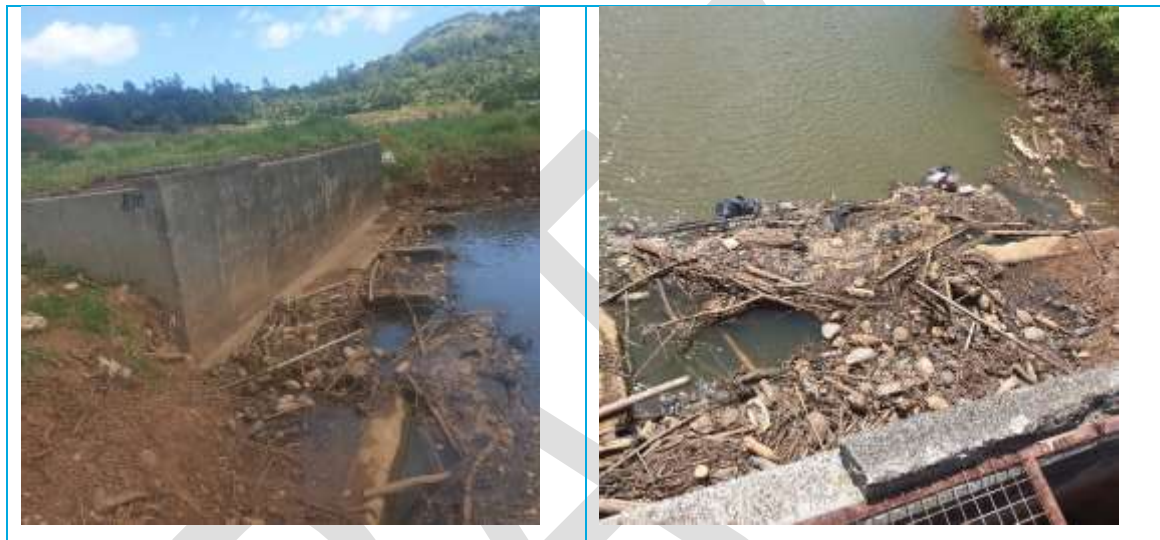
Figure 2-5: Levee and flood infrastructure at lower catchment (Source: Patrick Fong 2020)

Number of drainage and flood management actions have been undertaken within the catchment. In the late of 1970s a series of levees and floodgates constructed to protect reclaimed areas in the lower catchment. These operated relatively well until the last decade, when a reduction in performance was observed, considered due to an increased frequency of short-lived extreme rainfall events and the effect of sea level rise (GCCAPlus, 2020)⁵. Structural measures introduced in 1980's include dredging rivers and constructing seawalls.

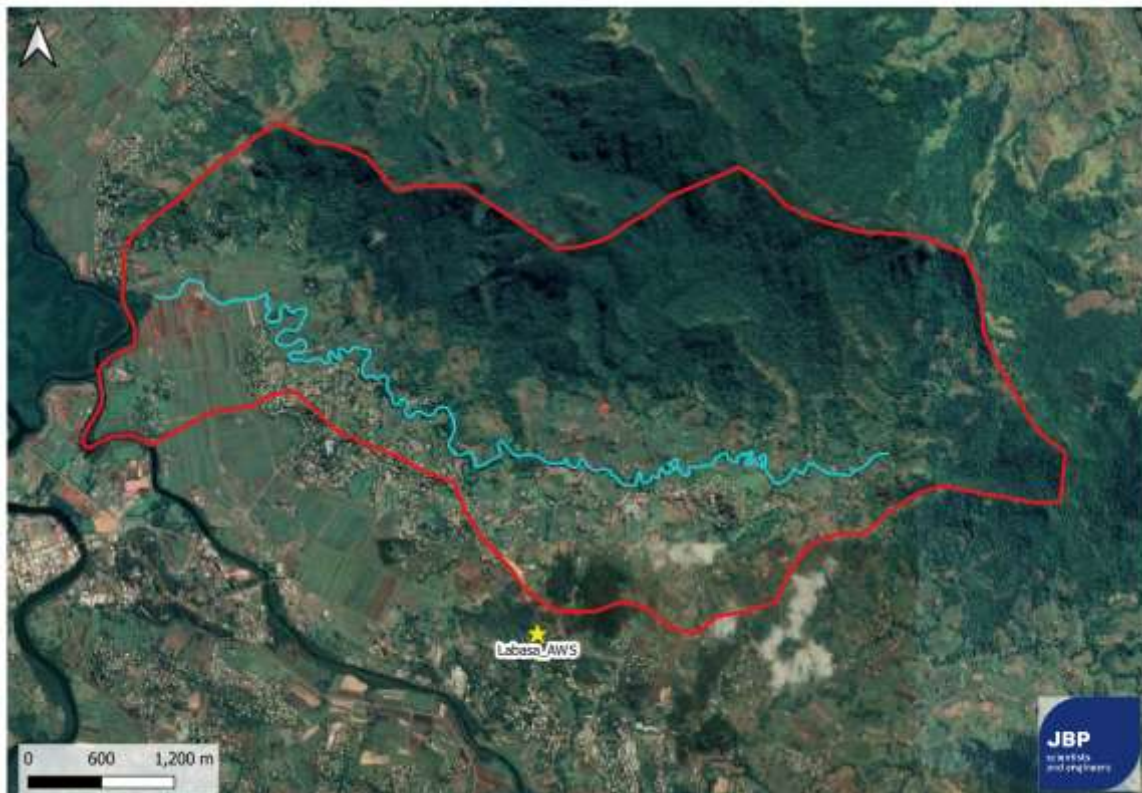
Figure 3-1: Closest Automatic Weather Station to the Soasoa catchment

Rainfall data was provided by the Hydrology Unit of the Fiji Department of Meteorology (Fiji Met). There is no gauging station in the proximity of Soasoa drainage area, therefore the gauging records of Labasa Automatic Weather Station (AWS) was used (see Figure 3-1). AWS data provided by Fiji Met was limited to two data series.

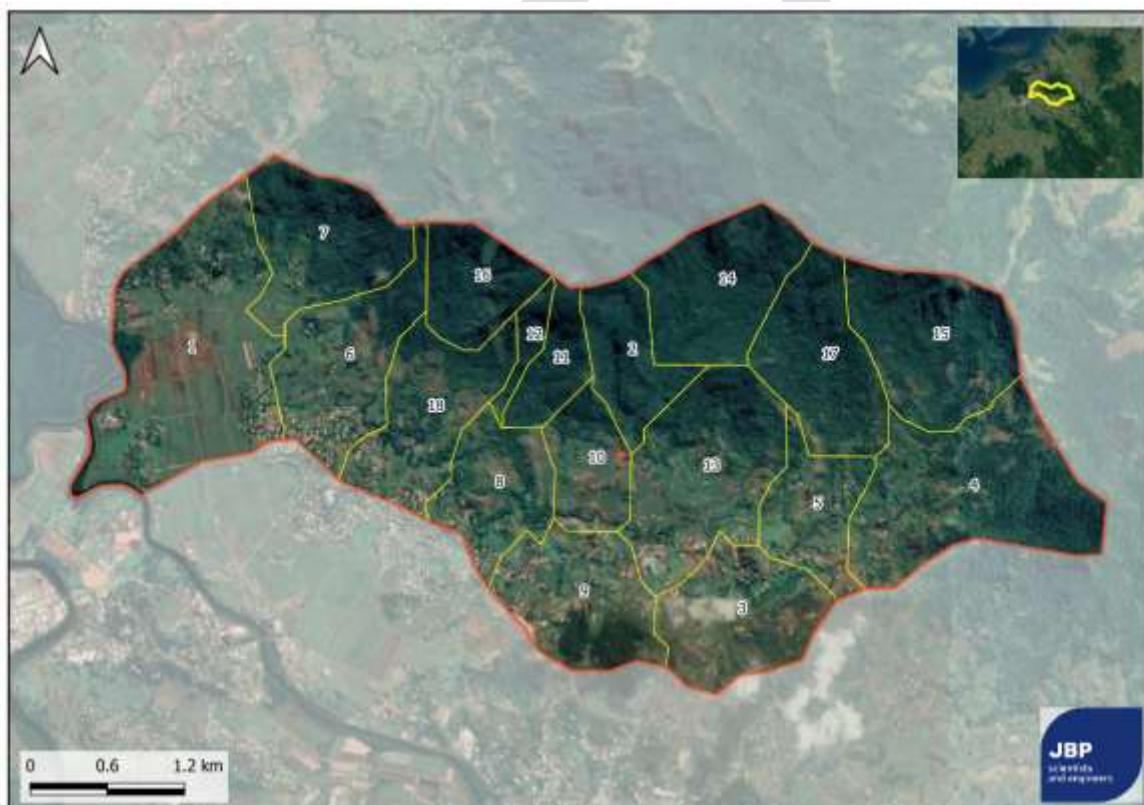
Figure 4-1: Soasoa subcatchment delineation

Catchment analysis and hydrological modelling was undertaken to understand how runoff flows through the catchment. Catchment delineation has been undertaken using the SRTM 1 second (~30m grid resolution). It was used to determine the Soasoa catchment, which was split into 18 discrete watersheds. All subcatchments were analysed to identify key statistics, including hill slope, catchment slope, flow route, stream network, gradient and catchment area. The drainage basin area was found to be 17.5 km², with steep upper regions with a hill slope gradient of 0.24, and a flat lower channel with a 0.12 gradient.

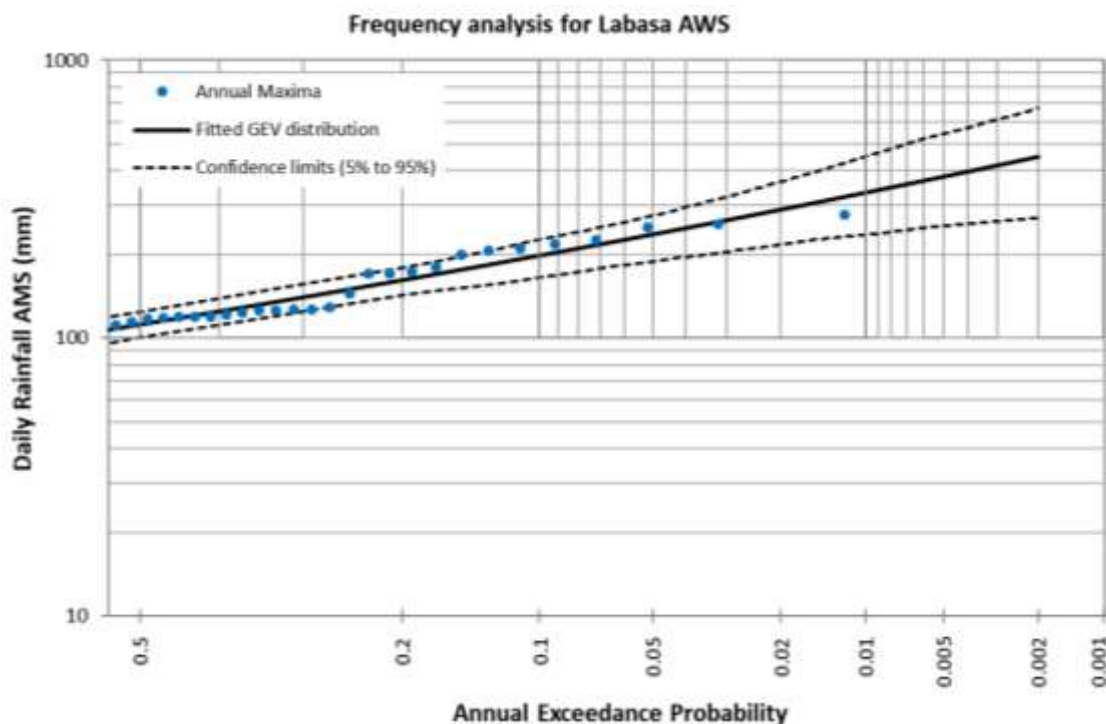
Figure 4-2: GEV L-Moments analysis of historical annual maxima series at Labasa AWS

A frequency analysis was applied to the 50 years of annual maximum daily rainfall provided by Fiji Met, which was used to estimate design rainfall for the standard return periods. The design rainfall was obtained based on the Annual Maxima Series, using the Generalised Extreme Value (GEV) fitted by probability weighted moments (see Figure 4-2). A summary of the design maximum daily rainfall for a range of return periods are provided in Table 4-2. For design flood modelling, temporal patterns have been based on TC Keni, which produced a worst flooding in the catchment.

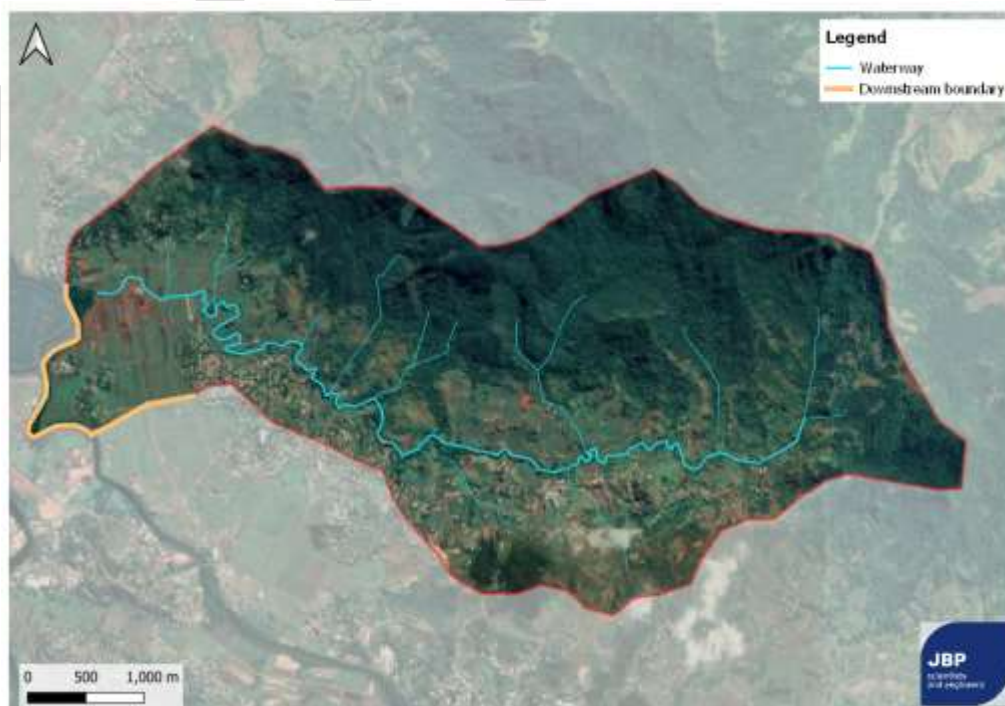
Figure 4-4: TUFLOW model configuration

The model covers an area of 18.8 km² of the catchment. The downstream boundary has been established at the outlet of Qawa River, where flood infrastructure has been observed (See Figure 2-5). The 2D modelling domain has a 10m grid resolution (i.e. it uses 10m x 10m cells), which reflects the catchment topography, with overland flow roughness based on land use. Watercourses were represented in model domain using lowered grid cells connecting lowest ground elevations along the watercourse. The model domain is shown in Figure 4-4.

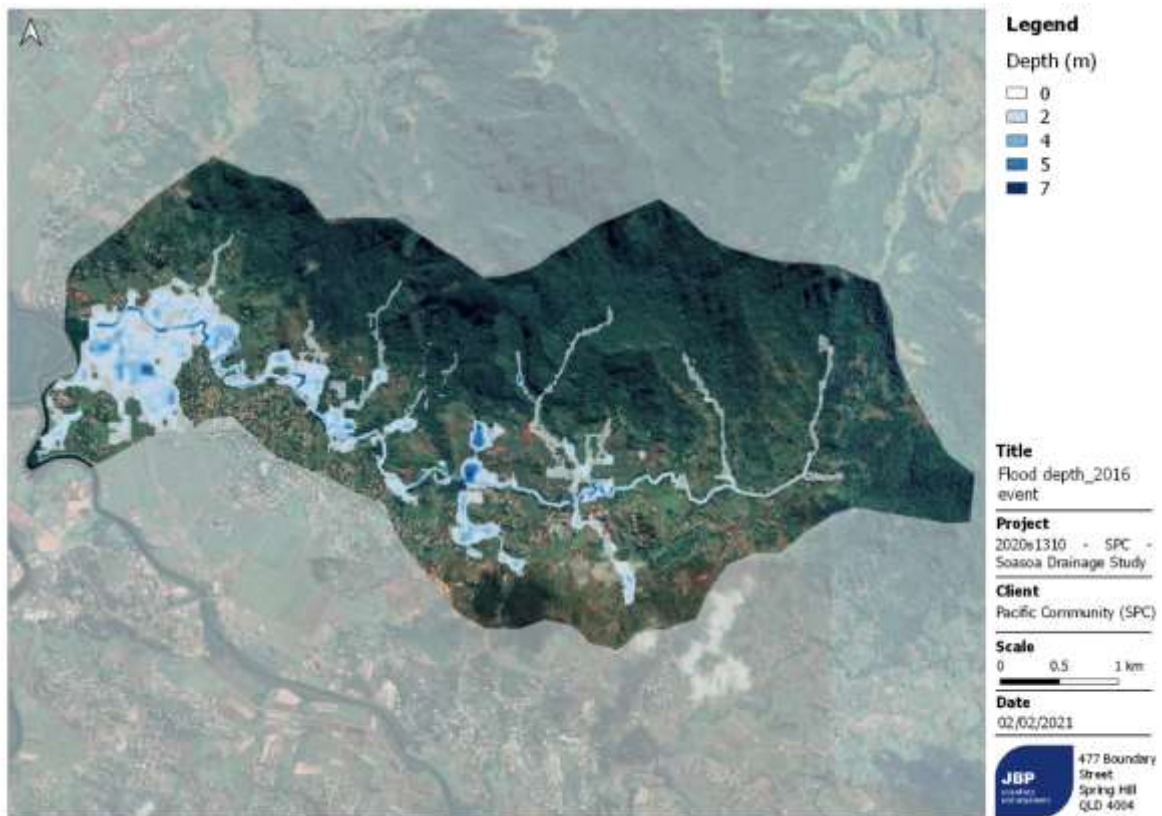
Figure 4-6: Flood depth in 2016 event (TC Victor)

Figure 4-6 and Figure 4-7 show flood mapping for the historical TC Victor (2016) and TC Keni (2018) events. Full details are shown in Appendix A, which includes information on depth, water level and velocity.

The flood extent for the two historical events shows that the lower reaches of the Nababuabua Creek are more vulnerable to flooding. Flooding in this area can inundate transport links, government assets and private properties. The upper reaches of the catchment are less prone to flooding, however given the high velocities may be prone to scour and erosion (see Appendix A).

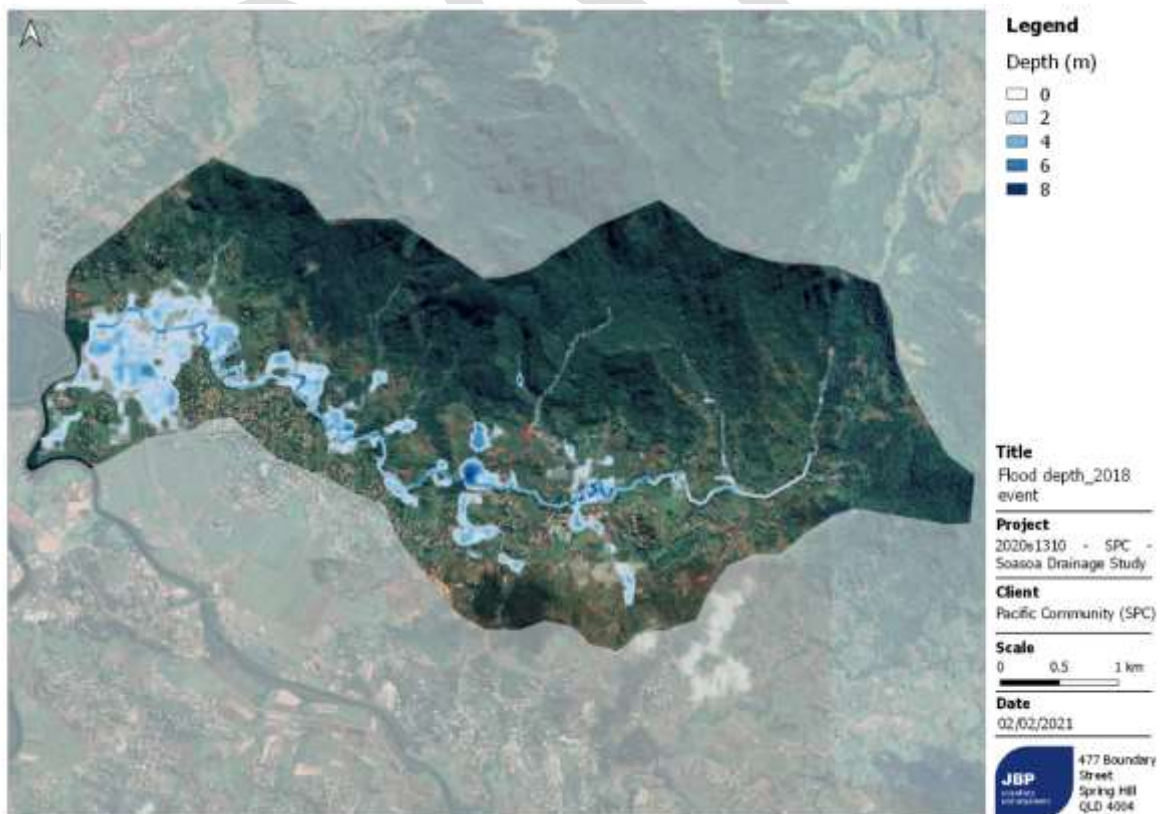
Figure 4-7: Flood depth in 2018 event (TC Keni)
