## SCALING UP PACIFIC ADAPTATION (SUPA)

### Report: Community-based impact assessment in Ewa & Ijuw Districts, Nauru

27<sup>th</sup> – 31<sup>st</sup> October 2020

## Community-based impact assessment conducted for Colorbond tanks in Nauru

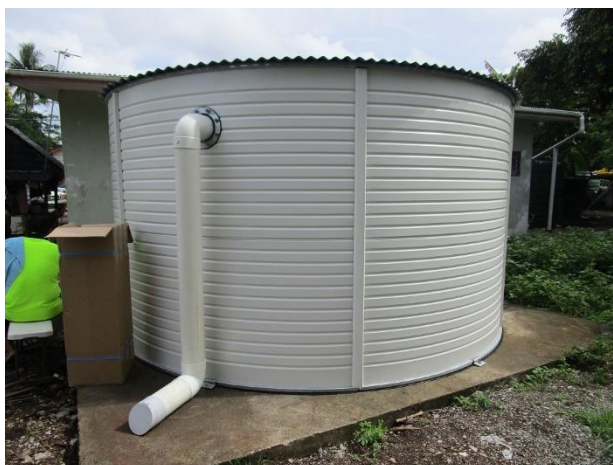
*A Colorbond tank that was installed in Nauru*

- The tank capacity is 19,000 litres with 2 taps, a side ladder, a manhole and an overflow pipe. The tanks are cream in colour and there was a total of 38 beneficiary households in Nauru.
