Coastal protection along the north coast of Tongatapu, Tonga (CPS 20/140) Report 1

Desktop Assessment and Community Priority Issues

Prepared for the GCCA+ SUPA Project
and the Kingdom of Tonga:

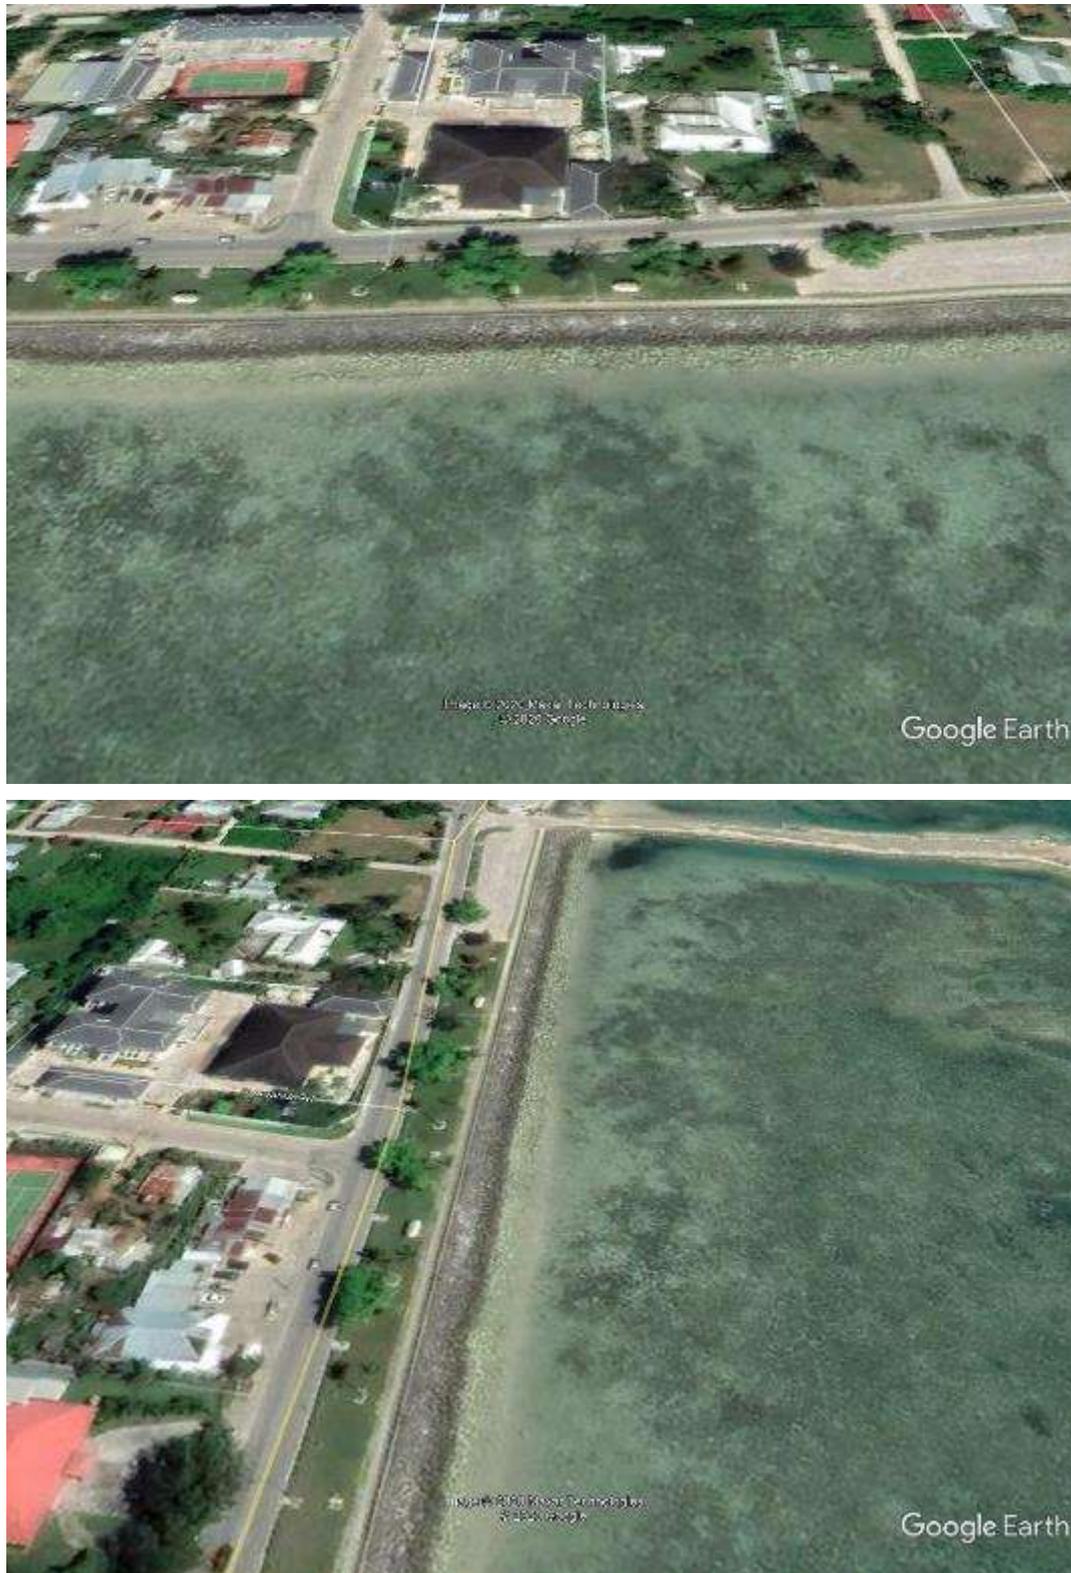
Figure 1.2. The Nuku'alofa coastline includes some 6.0 km of rock armour and port/wharf developments.

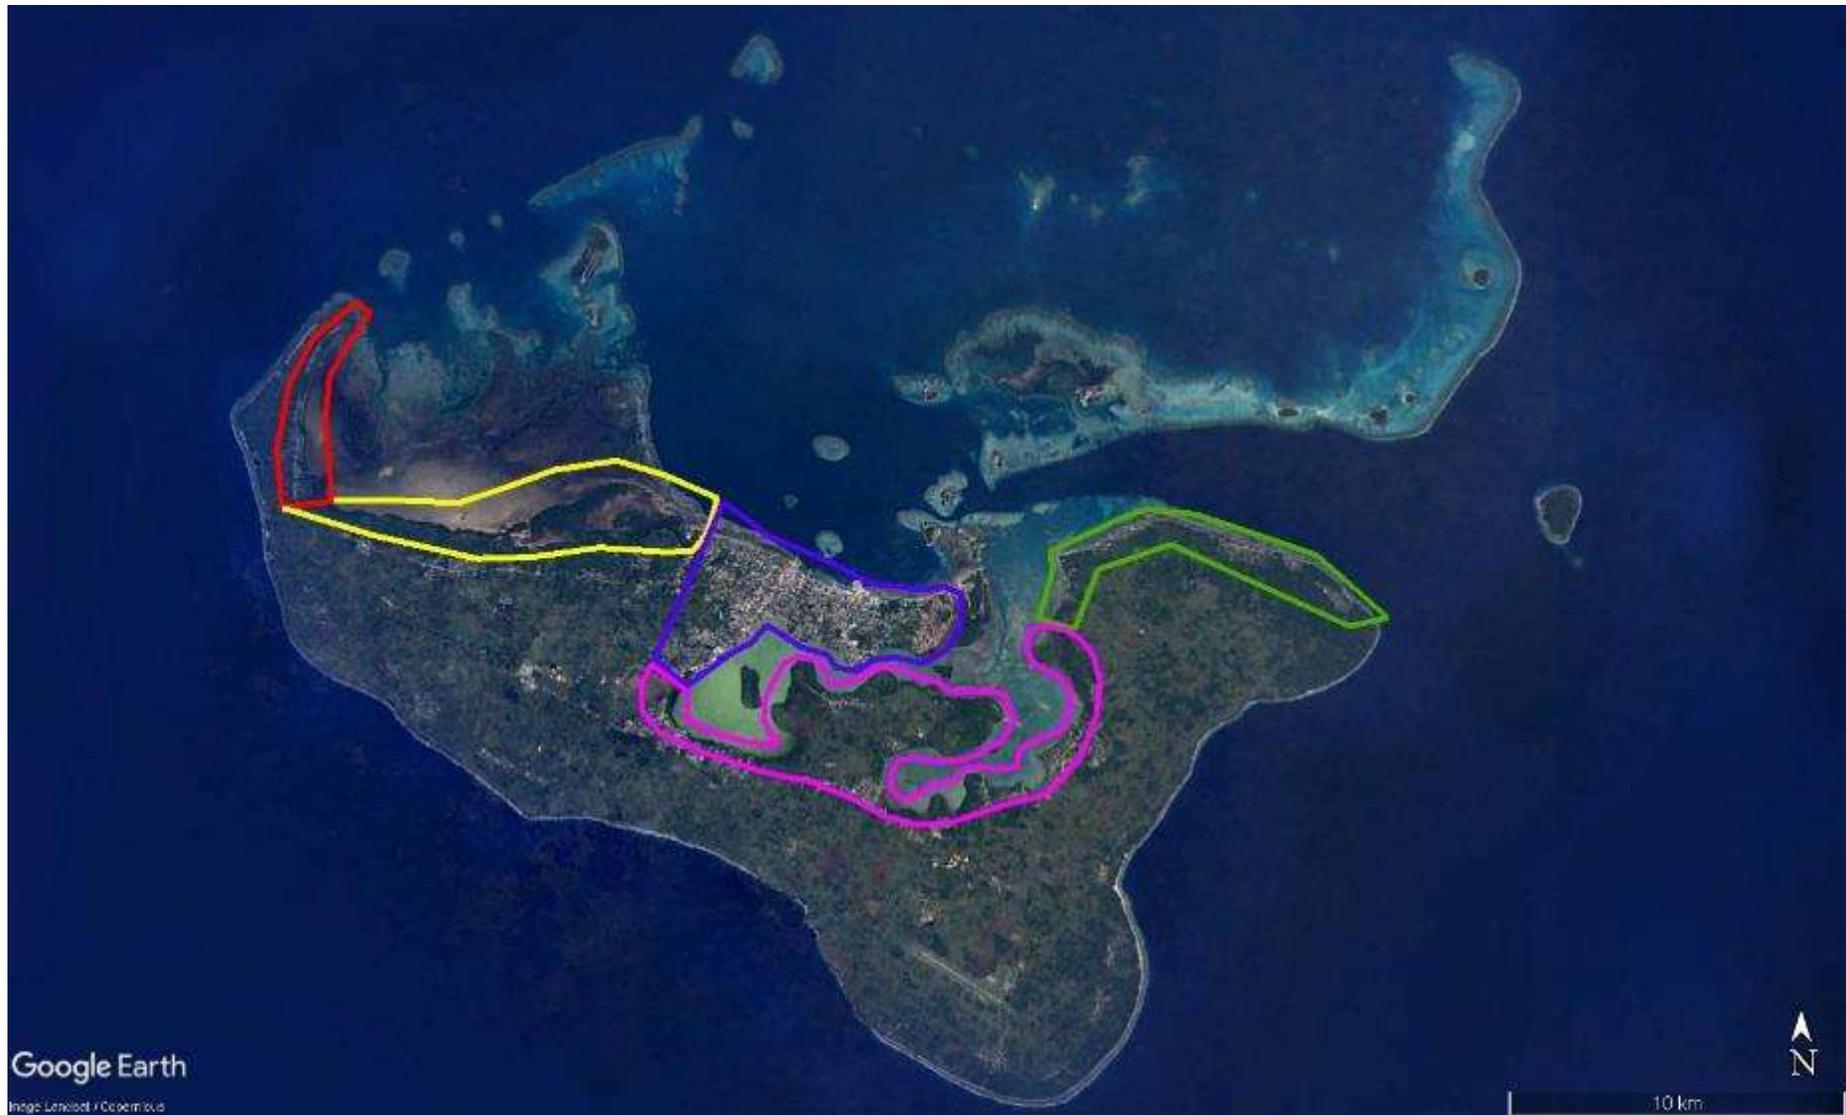
Figure 1.3 The five study sections along the northern coastline of Tongatapu, Kingdom of Tonga (Google Earth, 2020). Coastal Unit 1 = red, Coastal Unit 2 = yellow, Coastal Unit 3 = blue, Coastal Unit 4 = magenta and Coastal Unit 5 = green.

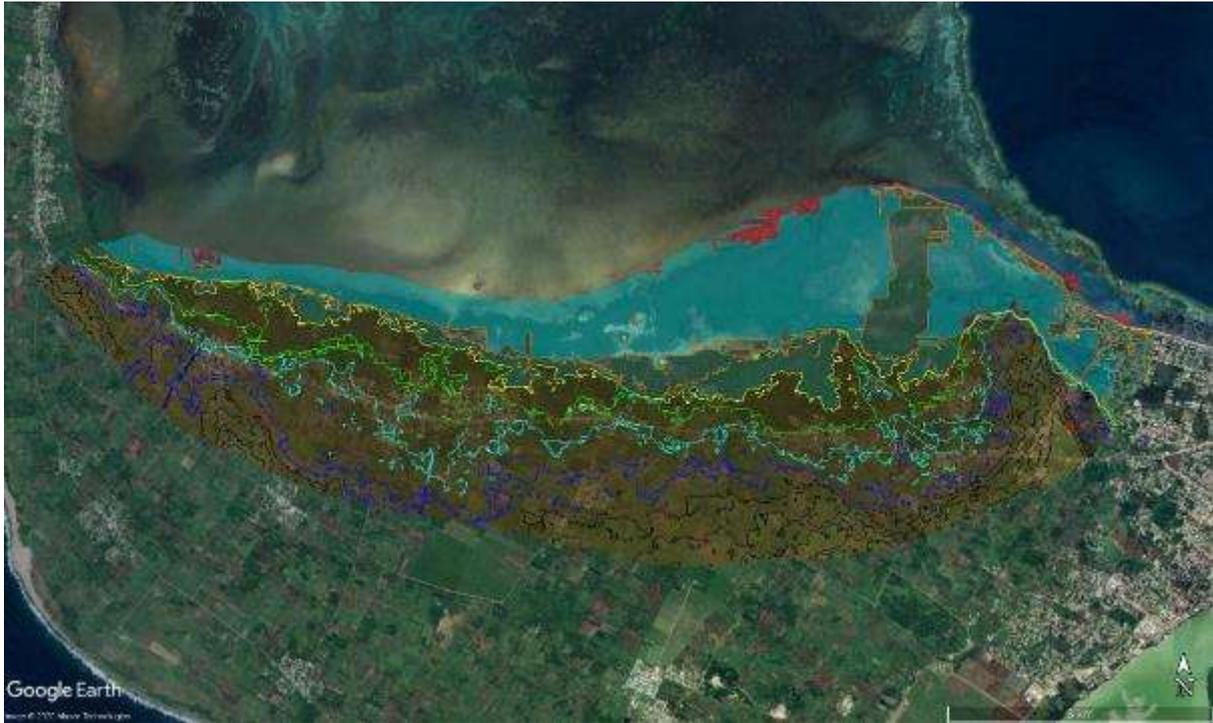
Figure 4.3. Elevation map of Coastal Unit 2. The red line represents MSL and the yellow line represents 2.0 m above MSL.

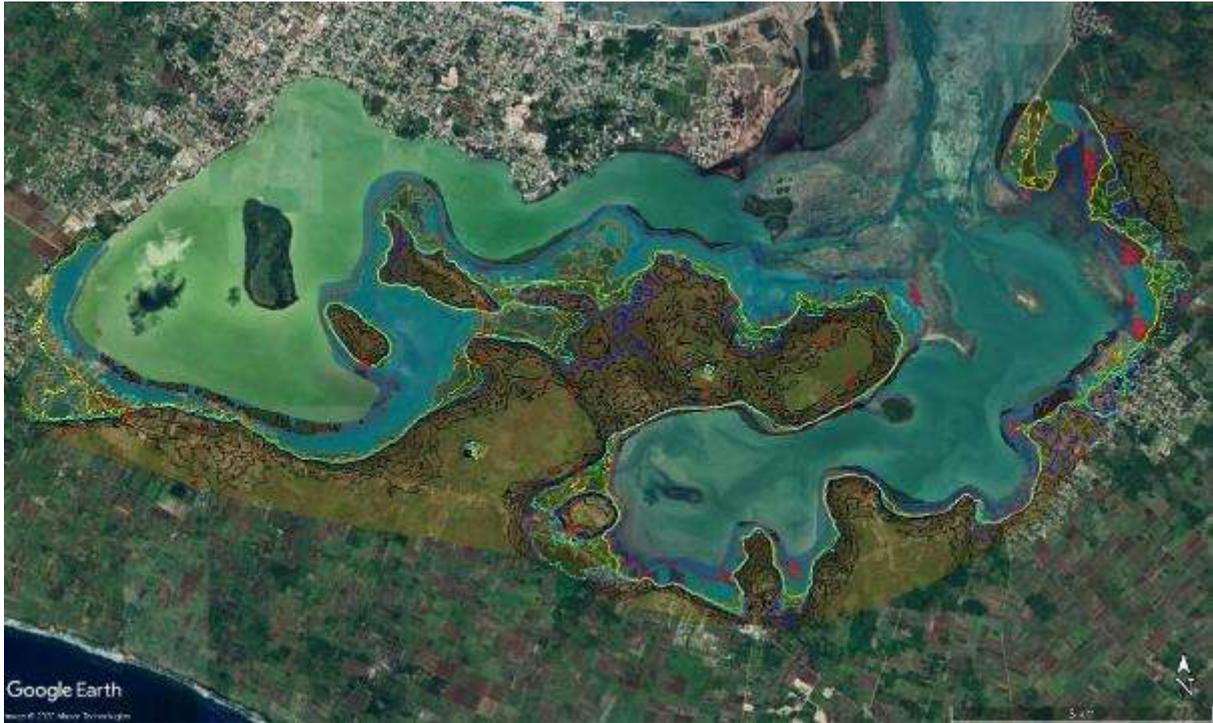
Figure 4.4. Elevation map of Coastal Unit 3. The red line represents MSL and the yellow line represents 2.0 m above MSL.

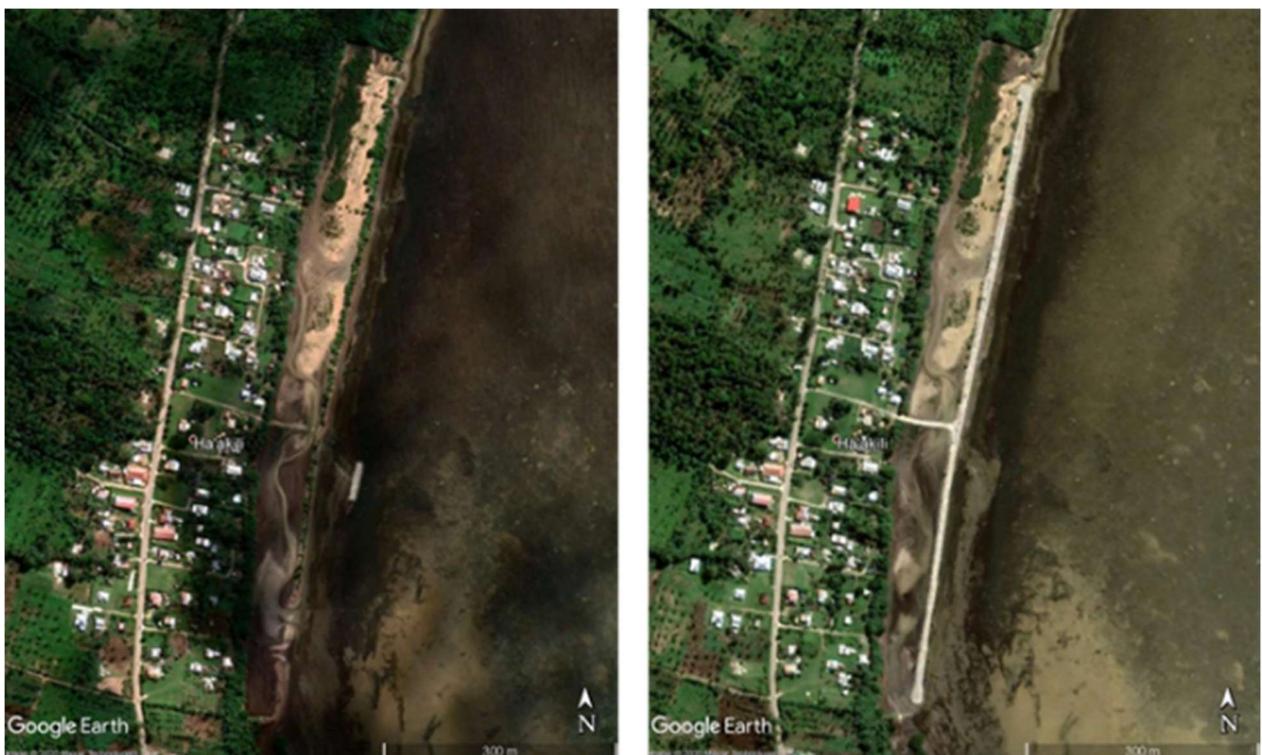
Figure 5.6 Revetment/breakwater upgrade at Ha'akili Village. Left and right images are from June 2018 and July 2019 (Images sourced from Google Earth, 2020).

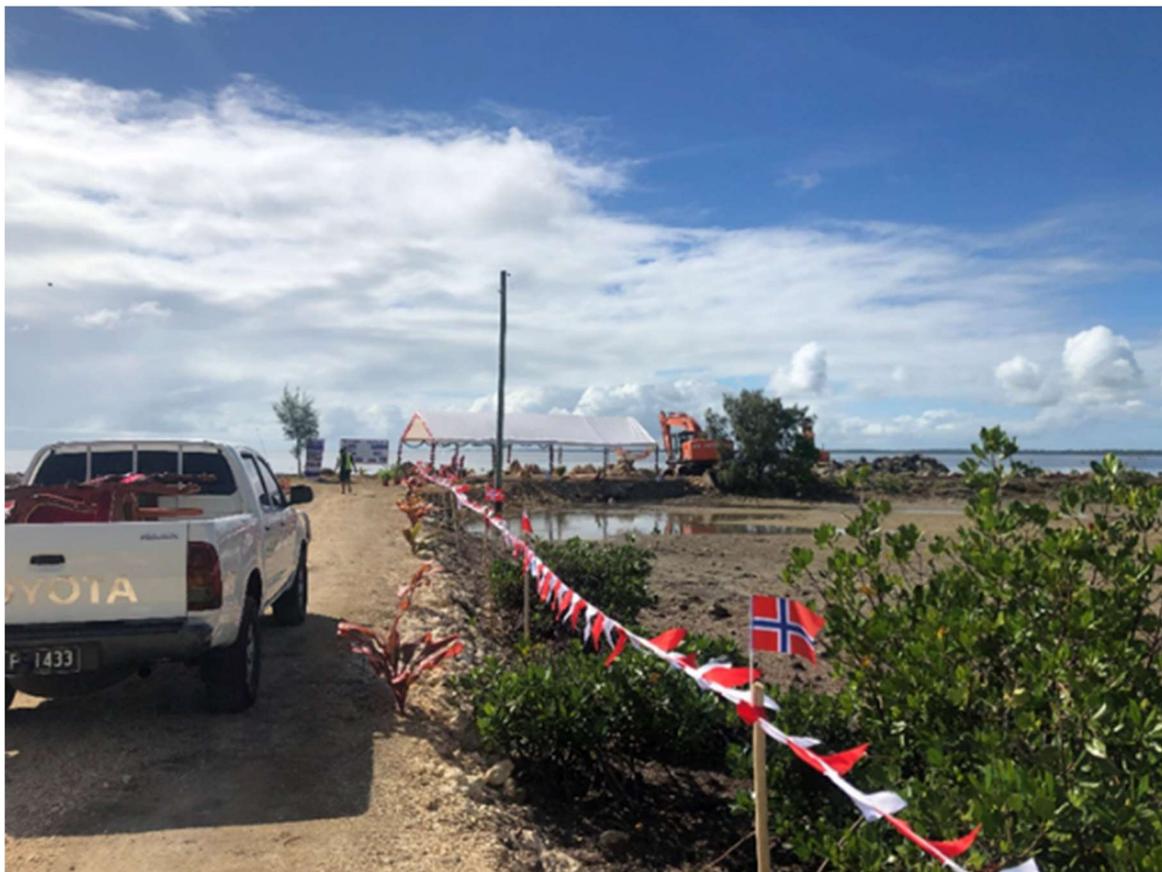
Figure 5.7 The temporary access road to the A’hau Barrier that requires complete removal on completion of the barrier project (Image sourced from Mead, 2019a).

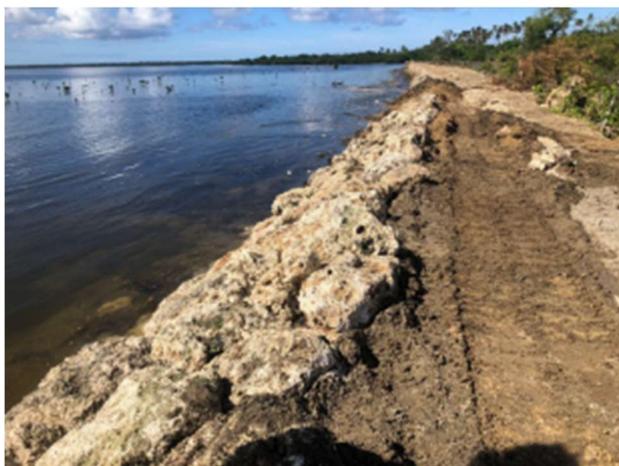
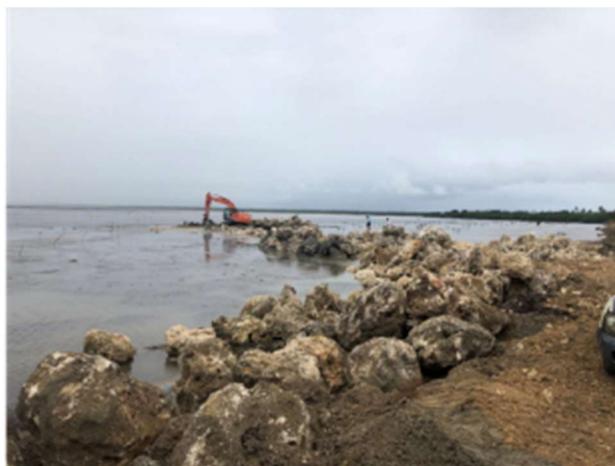
Figure 5.8 Left - Armour rock from the non-functional entrance that has been removed and placed as armour along the A’hau barrier. Right - The trial detached breakwater (which proved to have low efficacy along this coast due to the almost complete lack of sand) has almost been dismantled and the armour rock is being used to heighten and widen the A’hau barrier (Images sourced from Mead, 2019a).

Mead (2019a) carried out a construction evaluation of the western Tongatapu (Hihifo) climate change resilience trials. The construction involved: a) reinforcing the existing A'hau Barrier by the addition of armoured rock, b) opening to the southern entrance and widening the northern entrance to provide better flushing, and c) removing the access road across the middle of the of lagoon. In general, Mead (2019a) reported that the construction was progressing well and that the rock from the non-functional entrance had been removed, with the rock being used to armour and slightly heighten the seaward side of the barrier as well as to make a causeway road for construction (Figure 5.8). A detached breakwater once existed but has mostly been removed and the rock has been placed along the seaward side of the barrier (Figure 5.8).

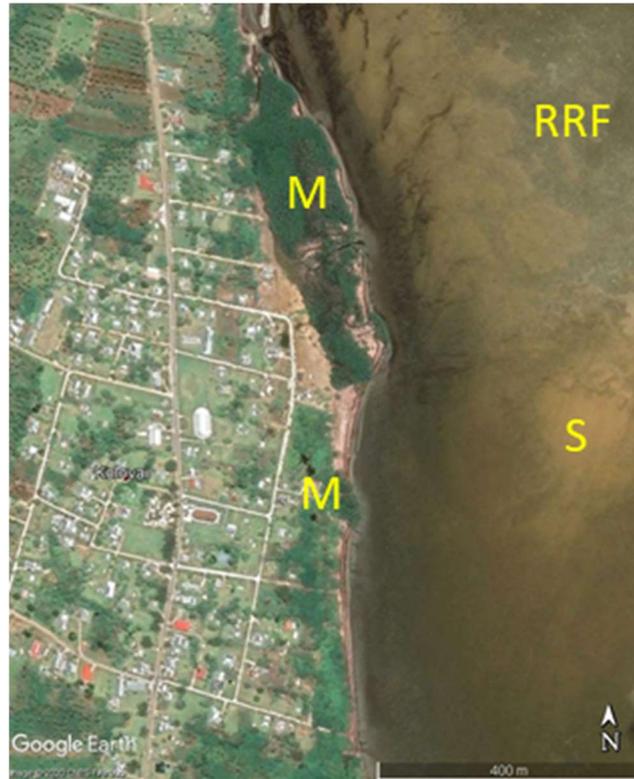
Figure 5.9 Image shows nearshore and shoreline bio-physical features of Kolovai village, Tongatapu, Kingdom of Tonga (Image sourced from Google Earth, 2020). Note: RRF = rocky reef flats, M = mangroves, and S = sediment.

The nearshore environment of Kolovai is characterised by intertidal reef flats, which have an increasing veneer of sediment overlying (Figure 5.9). Again, the veneer increases in thickness southward toward Ha'avakatolo village. The mangroves in the north border Ha'akili village. The mangroves in the middle of the appear to have somewhat been removed.

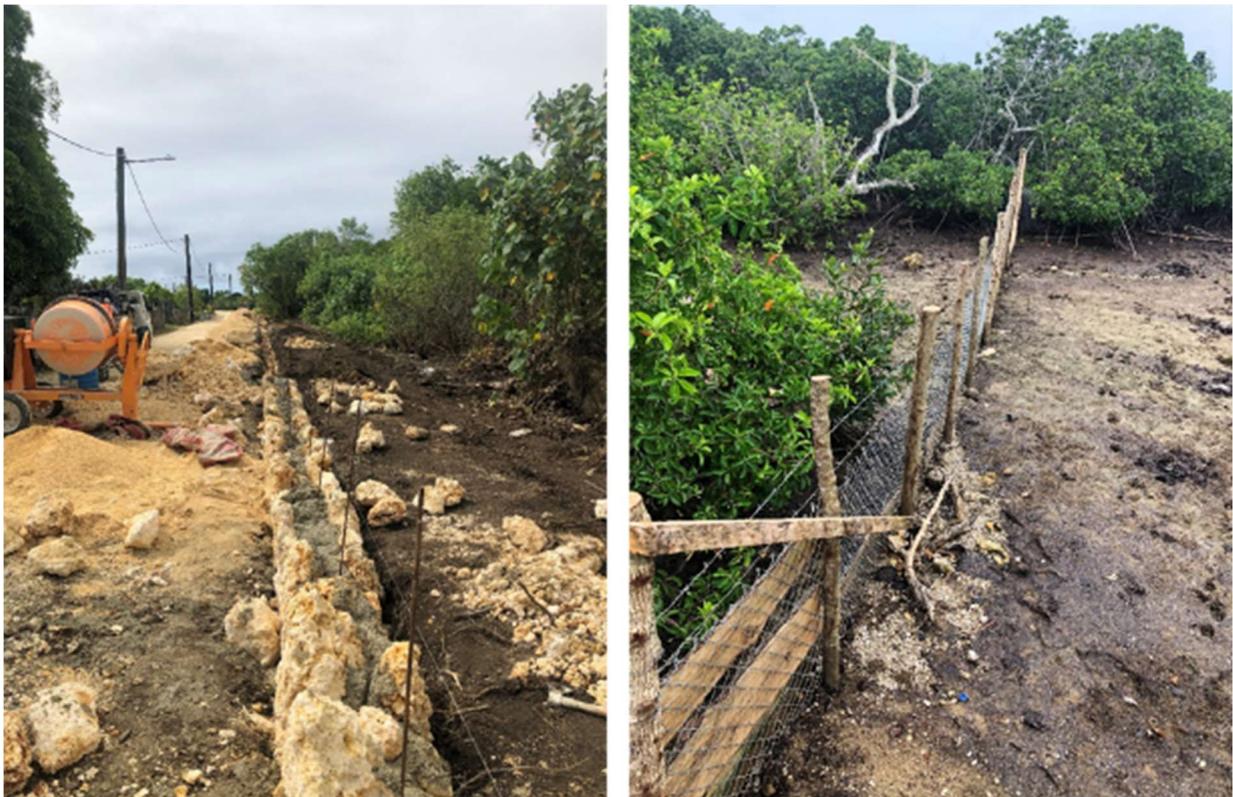
Figure 5.10 Left – Construction progress of the Kolovai Seawall. Right – One of the new pig exclusion fences to protect the mangrove restoration areas (Images sourced from Mead, 2019a).

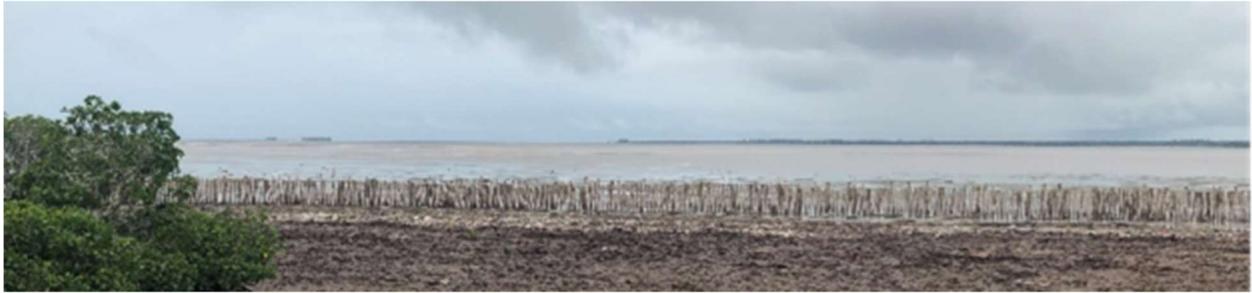
Figure 5.11 Wooden groyne constructed to help protect mangrove seedling establish from the impacts of waves (Image sourced from Mead, 2019a).

In general, Mead (2019a) reported that the works were progressing well with 80 m of the seawall footing prepared (Figure 5.10). Mead (2019a) also reported to have observed pigs that could not get around the new fence (to forage in the mangrove restoration area (Figure 5.10)). The wooden groyne was noted to be impressive and would serve the purpose of protecting mangrove seedlings well (Figure 5.11).

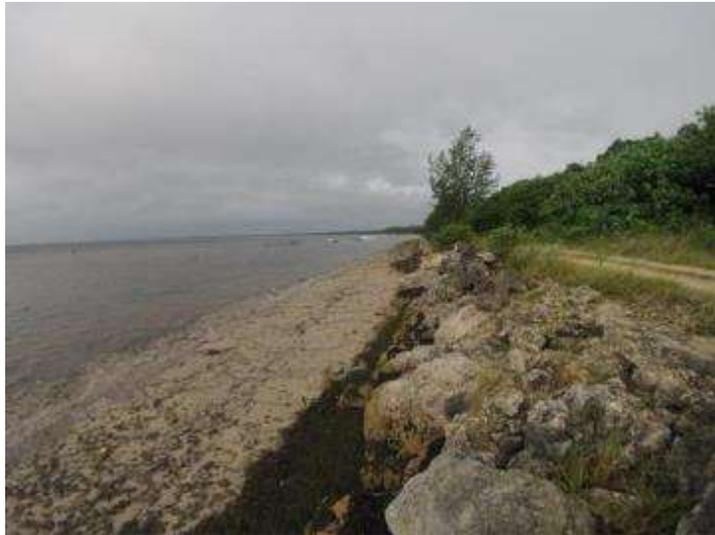
Figure 5.13 The coastal road/revetment that has halted erosion at Ha'atafu and Kanokupolu villages but closed off the lagoon that was naturally produced sometime between 1968 and 1979 (cited in Mead & Aktin, 2014).

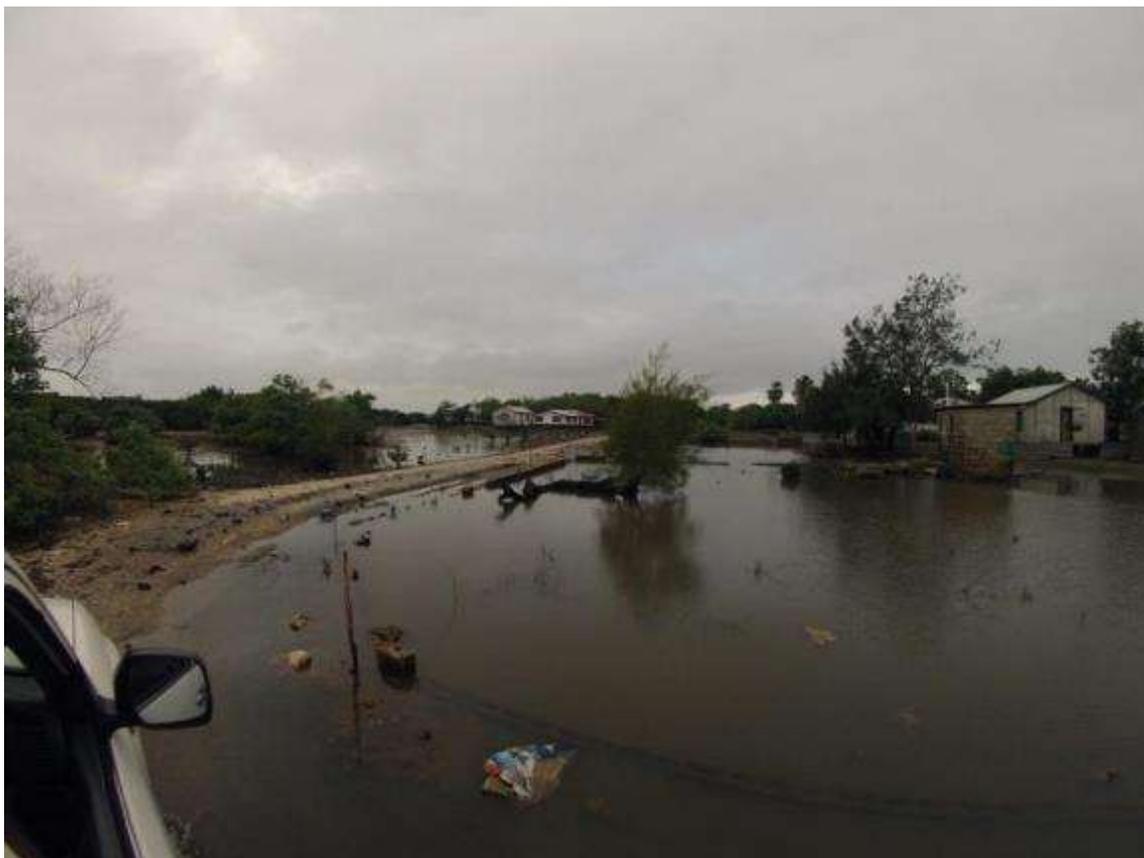
Figure 5.14 Mangrove clearing and reclamation for houses in eastern Kolovai.

SLL (2014a) state that in the southern parts of the study area, mangroves are being removed, land-reclaimed and the village is advancing seawards. Mangrove clearing and reclamation was observed in Kolovai and Ha'avakatolo during the recent site visit (Figure 5.14), and is clear on satellite images of the area. Reduction in the wetland and mangrove areas means that the land is more susceptible to flooding (cited in Mead *et al.*, 2014).

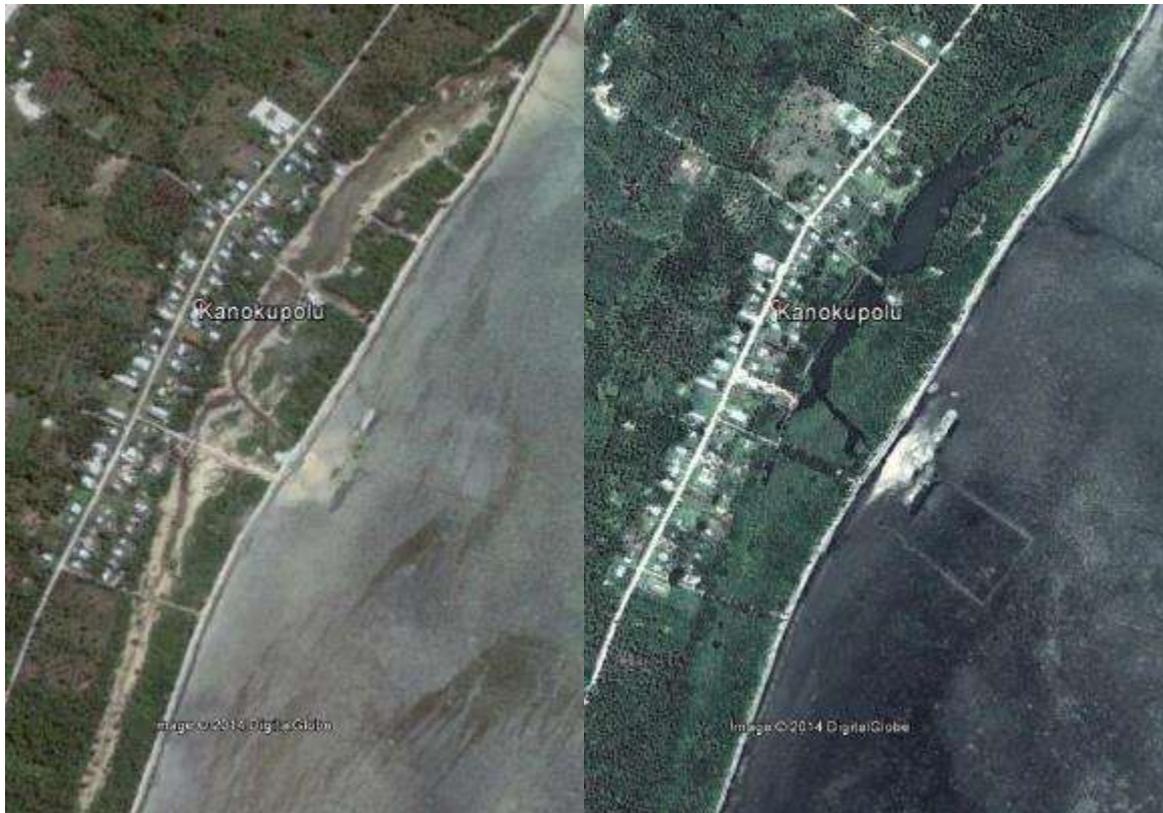
Figure 5.17 The Kanokupolu lagoon in 2005 after closure by the construction of the coastal road/revetment (left), has been continually reduced in size (especially in the north and south) (right – April 2013).

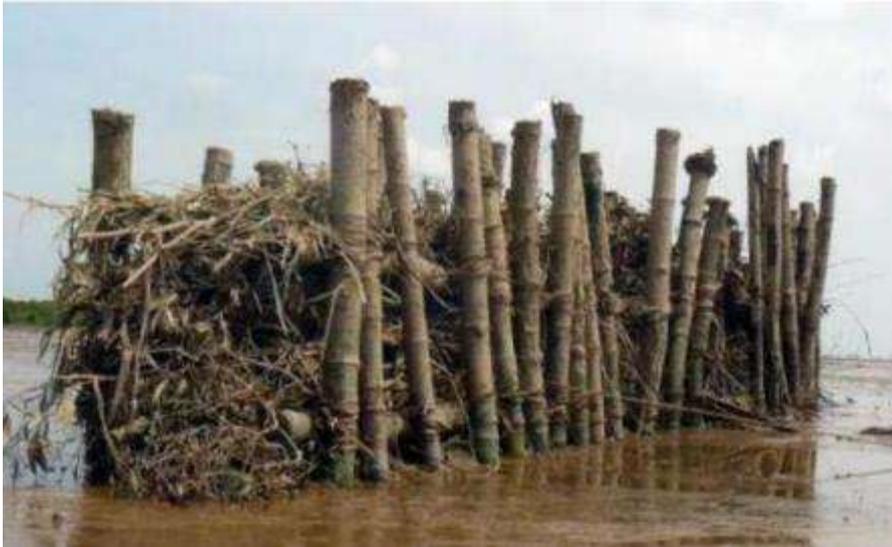
Figure 5.18 An example of a bamboo/brushwood groyne (SSL, 2014b; cited in Mead *et al.*, 2014).

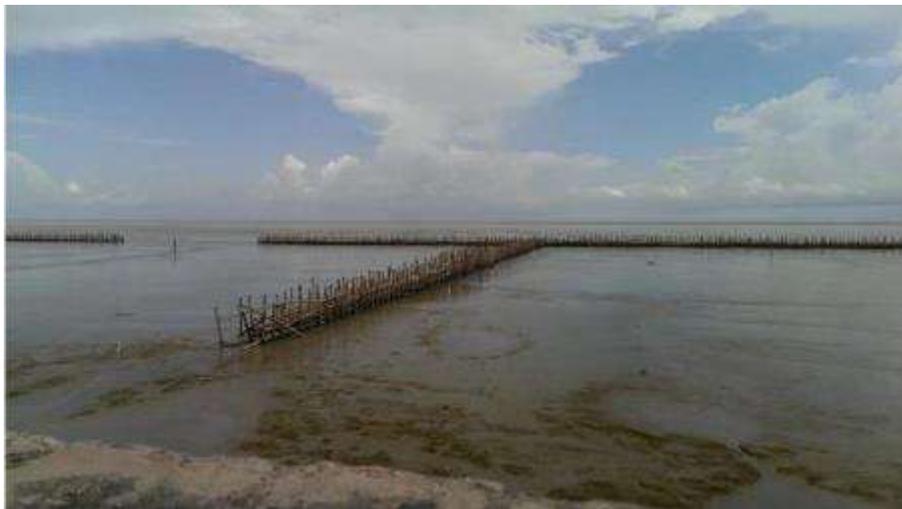
Figure 5.19 An example of a bamboo/brushwood groyne and sedimentation field (SSL, 2014b; cited in Mead *et al.*, 2014).

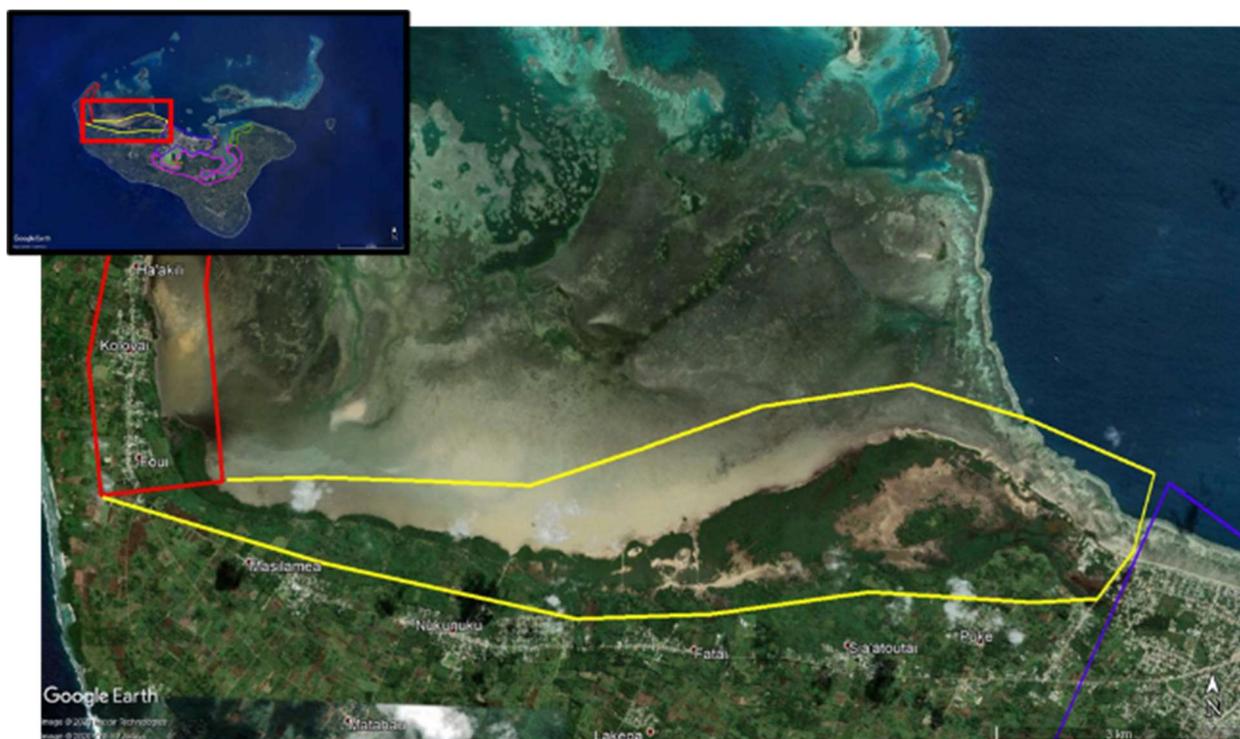
Figure 6.1 Location map of coastal unit 2 (yellow line) on the north-western middle coastline of Tongatapu between Foui to Sopus (Google Earth, 2020) .

The coastal unit between Foui and Sopus is characterised by a thin mangrove stand that thickens from west to east (Figure 6.1). This area is low lying and very susceptible to inundation (Figure 4.3) with most of this coastal unit below 2.0 m. This coastal unit faces north towards the shallower western section of the Tongatapu Lagoon. The section of coastline is protected from the prevailing south-east winds but is exposed to northerlies. Similar to coastal unit 1, the wave climate along coastal unit 2 is considered to be small <1.0 m under normal conditions, as waves break on the offshore barrier reef system and wave energy is further dissipated over the shallow western section of the Tongatapu Lagoon.

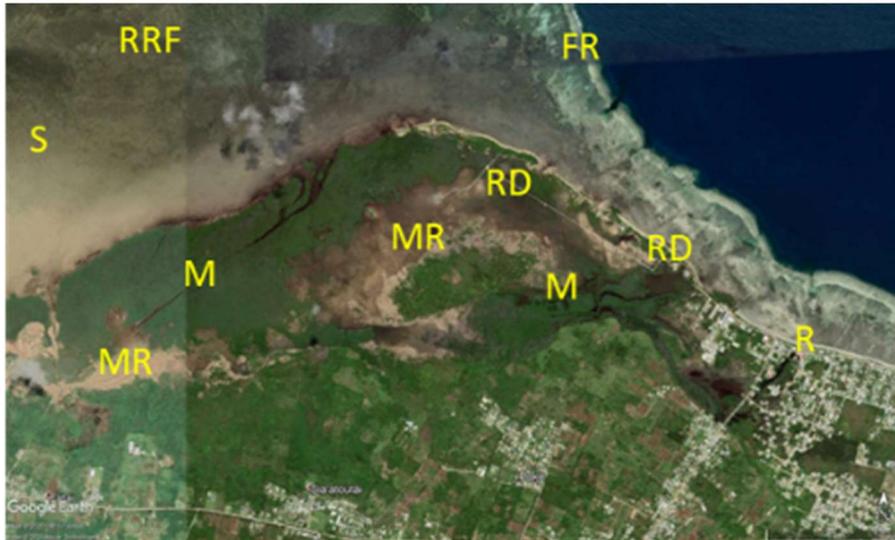
Figure 6.5 Image shows nearshore and shoreline bio-physical features between Sia'atoutai and Sopu villages, Tongatapu, Kingdom of Tonga (Image sourced from Google Earth, 2020). Note: RRF = rocky reef flats, M = mangroves, MR = mangrove removal, FR = fringing reef and S = sediment.

The nearshore environment between Sia'atoutai and Sopu villages is characterised by intertidal reef flats, which have a veneer of sediment overlying in the western portion, which thins toward the fringing reef in the eastern portion (Figure 6.5). Beyond the fringing reef, the water depth drops away rapidly to about 27 m depth CD. Adjacent to Sia'atoutai, the mangrove stand is widest (~1.2 km). Just to the east of Sia'atoutai, however, mangrove removal is evident, which is indicated by the brown patches (Figure 6.5). A road extends from the coastline adjacent to Sopu toward a house in the clearing (Figure 6.6).

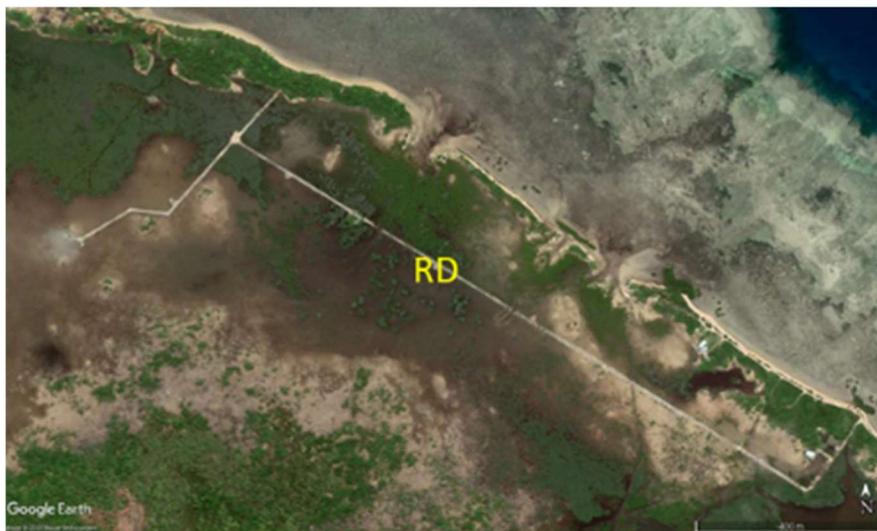
Figure 6.6 Image shows a road adjacent to Puke Village going to a house in the clearing, Tongatapu, Kingdom of Tonga (Image sourced from Google Earth, 2020).

From the northern most tip of land, the shoreline changes from mangroves to the west to a broken sandy beach system to the east. This is indicative of a change in environmental energy from low to high. From where the above-mentioned road begins (Figure 6.6), a revetment has been constructed, which appears to be protecting a small land bridge connecting the road to the coastline adjacent to Sopu Village. Directly adjacent to Sopu village the shoreline is characterised by a thin beach, which extends to a groyne at Nuku'alofa.

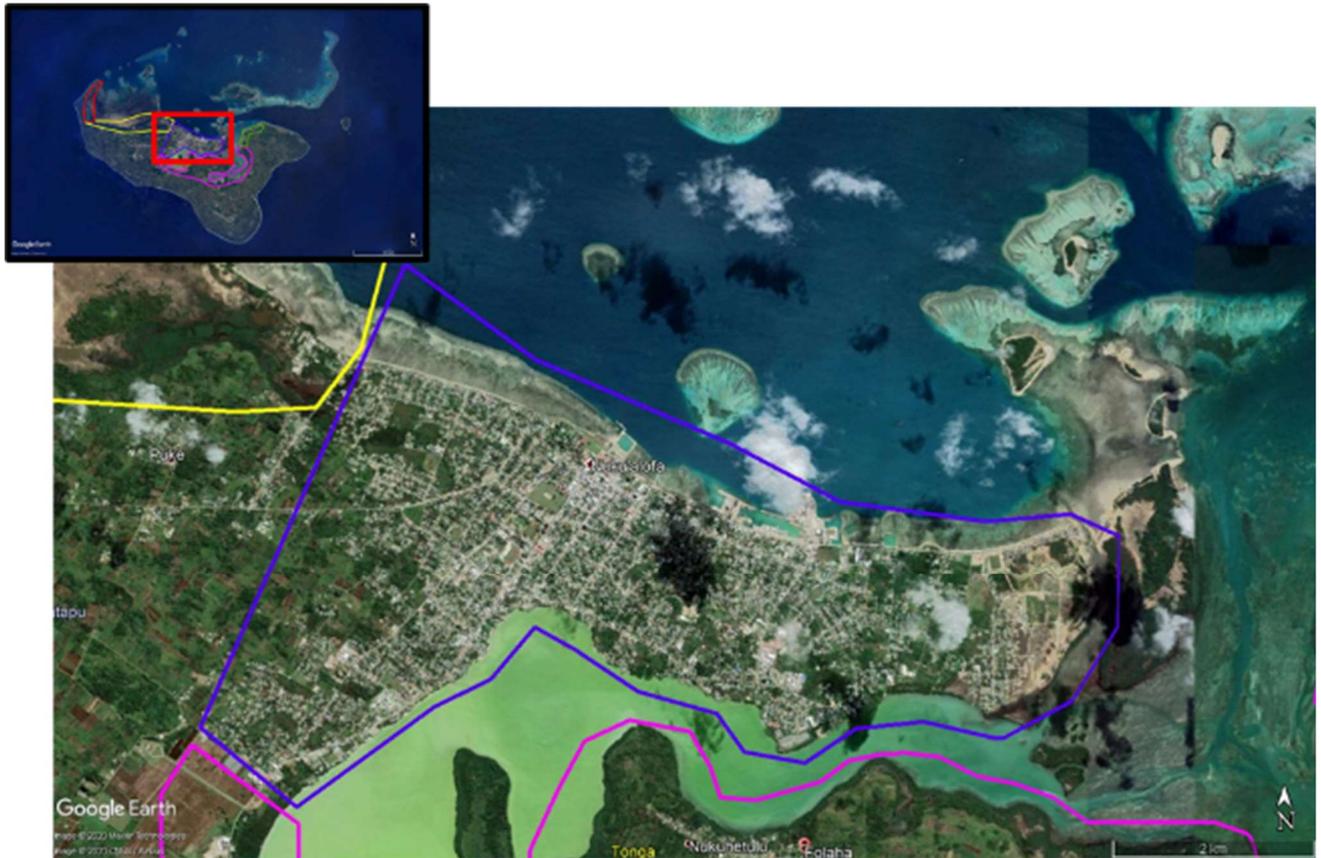
Figure 7.1 Location map of coastal unit 3 (blue line) on the northern most section of coastline of Tongatapu between Sopo and Nuku'alofa (Image sourced from Google Earth, 2020).

The coastal unit between Sopu and Nuku'alofa comprises two geographical components: a northern coastal area and a southern lagoonal area (Figure 7.1). The northern coastal area nearshore environment comprises a fringing reef, which drops off into the deep waters of the Tongatapu Lagoon. Similar to coastal unit 2, unit 3 is low lying and very susceptible to inundation (Figure 4.14). There are three pockets of higher ground that are greater than 2 m but most of this area is less than 2 m depth (

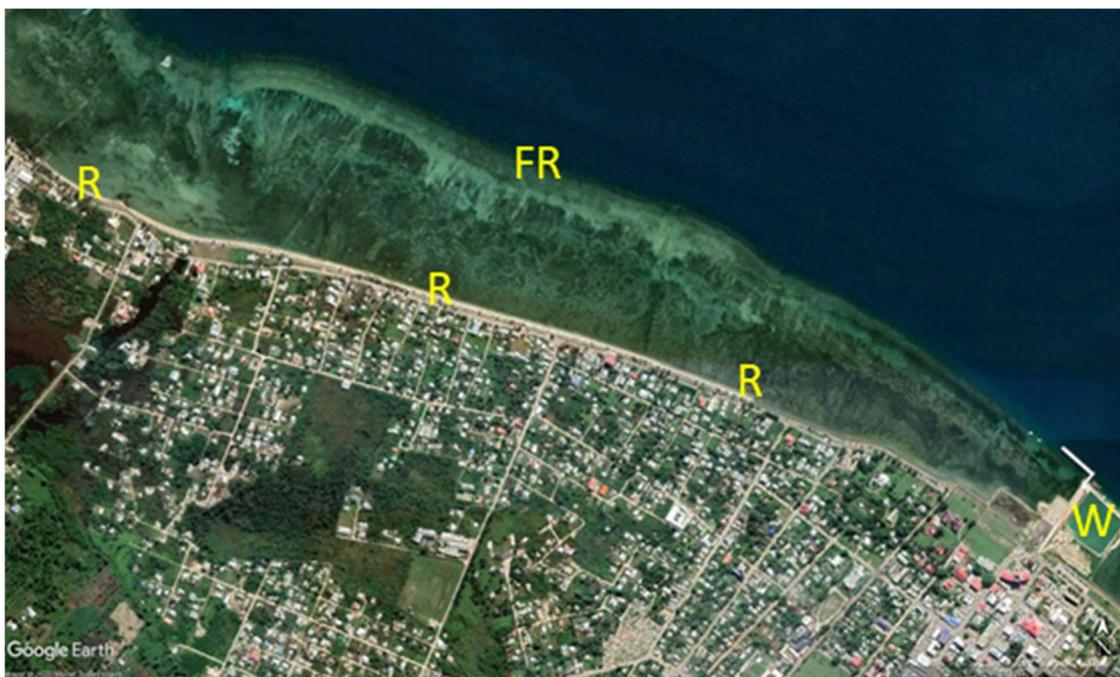
Figure 7.3 Image shows close up of the western area of the northern coastline of coastal unit 3, Tongatapu, Kingdom of Tonga (Image sourced from Google Earth, 2020). Note: FR = fringing reef, R = Revetment, W = Wharf.

The western area of the northern coastal shoreline is characterised by the Nuku'alofa seawall (Figure 7.3). This seawall was first built in 1977 and rebuilt after Cyclone Issac in 1982. By 1986, the seawall was revamped to a total length of 3.4 km (Figure 7.4) (Mimura & Pelesikoti, 1997). Today the seawall extends from east of Sopu to Popua (>6.0 km).

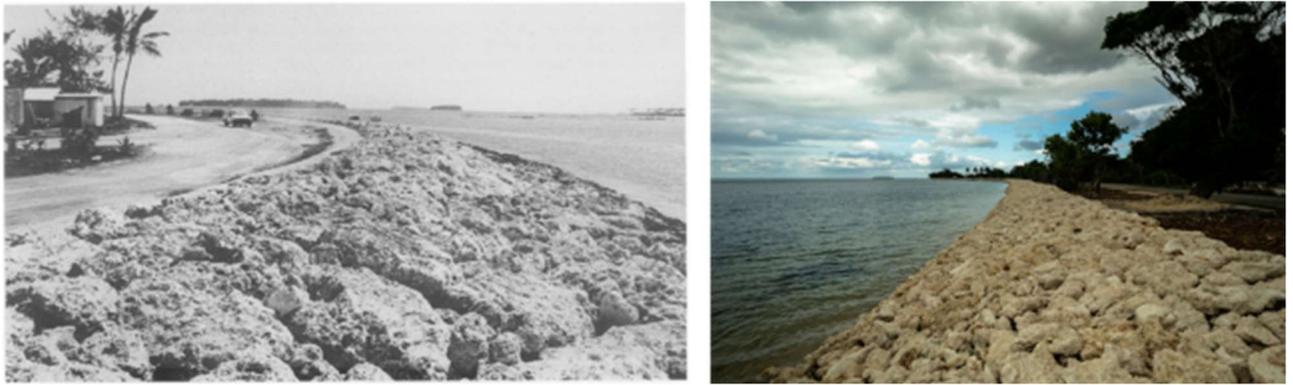
Figure 7.4 Nuku'alofa Seawall (Images sourced from Mimura & Pelesikoti, 1997 (left); Asian Development Bank – Flickr, 2020 (right)).

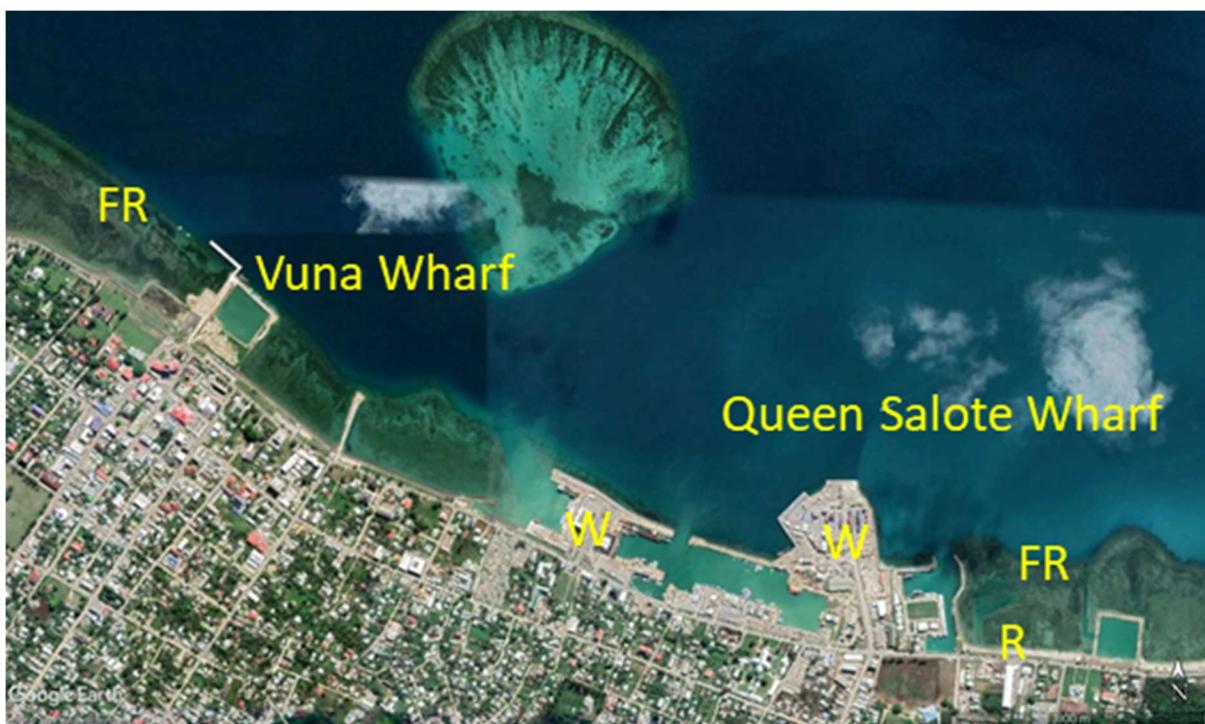
Figure 7.5 Image shows close up of the middle area of the northern coastline of coastal unit 3, Tongatapu, Kingdom of Tonga (Image sourced from Google Earth, 2020). Note: FR = fringing reef, R = Revetment, W = Wharf.

The middle northern component is characterised by the Vuna and Queen Salote Wharfs (Figure 7.5) with revetments/ breakwaters constructed between these. Constructed sometime around the 1860s, the Vuna Wharf is one of the oldest ports of call in the South-Pacific and enabled early commerce with the British and Germans traders. In 1902, the Vuna Wharf was opened for international trading. For nearly 120 years Vuna Wharf endured earthquakes and cyclones and was later suspended. In 2012, Vuna Wharf was resurrected, redeveloped, and re-opened by His Majesty King Tupou VI (Figure 7.6). Currently, the wharf is opened to cruise liners, foreign naval ships and vessel (Ports Authority Tonga, 2017).

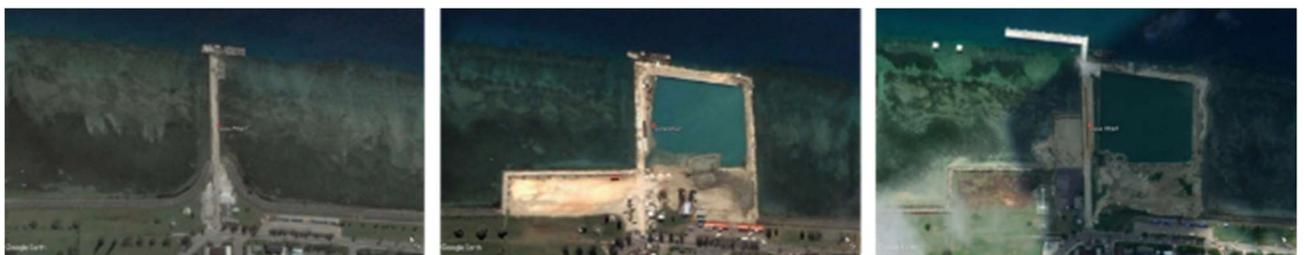
Figure 7.6 Images show progressive development (left to right) of the Vuna Wharf Upgrade. Images dated as 09/03/2002, 16/07/2009, and 17/06/2020 (Images sourced from Google Earth, 2020).

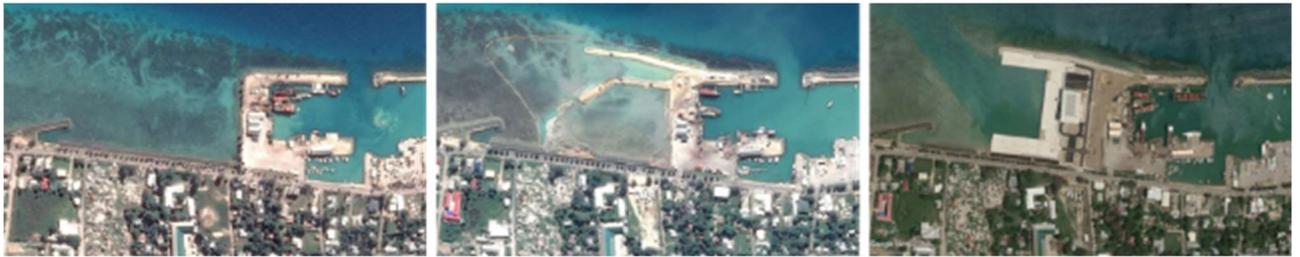
Figure 7.7 Images show progressive development (left to right) of the domestic transport upgrade for Queen Salote Wharf. Images dated as 18/07/2014, 02/06/2016, and 12/01/2018 (Images sourced from Google Earth, 2020).

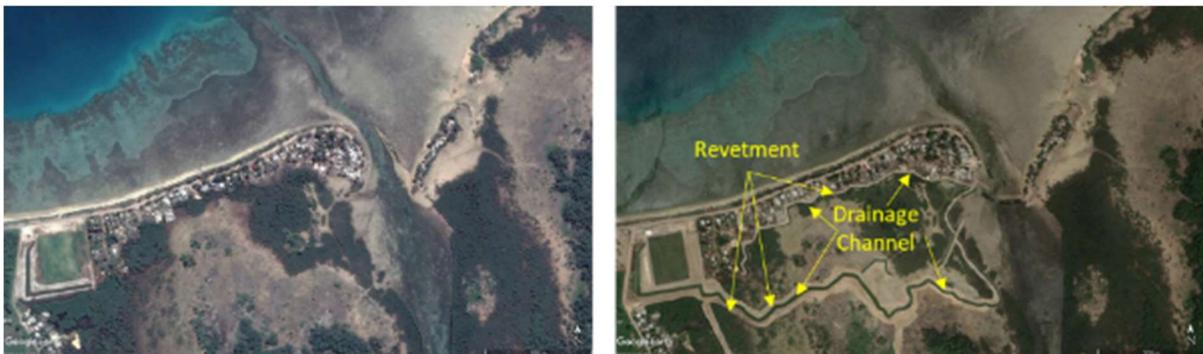
Figure 7.10 Pre-(02/06/2016) and post- (12/01/2018) revetment and drainage channel construction images for the eastern most area of the northern coastline of coastal unit 3 Tongatapu, Kingdom of Tonga (Image sourced from Google Earth, 2020).

Along the southern urban boarder of the town at the eastern extent of the peninsula (Figure 7.10) revetments and bunds, as well as drainage channels have been constructed, between June 2016 and present. Furthermore, the small township on the western side of Nukunukumotu Island, Seisia has also had bunds constructed, sometime between September 2019 and April 2020, which area current still be under construction (Figure 7.9 and Figure 7.11), as discussed in Annex I.

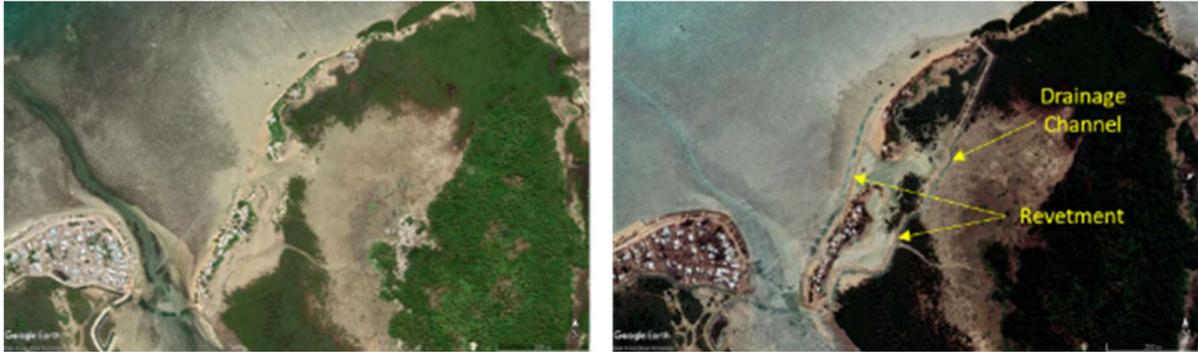
Figure 7.11 Pre- (29/09/2019) and post- (21/04/2020) revetment and drainage channel construction images for the western side of Nukunukumotu Island, Tongatapu, Kingdom of Tonga (Image sourced from Google Earth, 2020).
