Coastal protection along the north coast of Tongatapu, Tonga (CPS 20/140) Report 1

Desktop Assessment and Community Priority Issues

Prepared for the GCCA+ SUPA Project
and the Kingdom of Tonga:

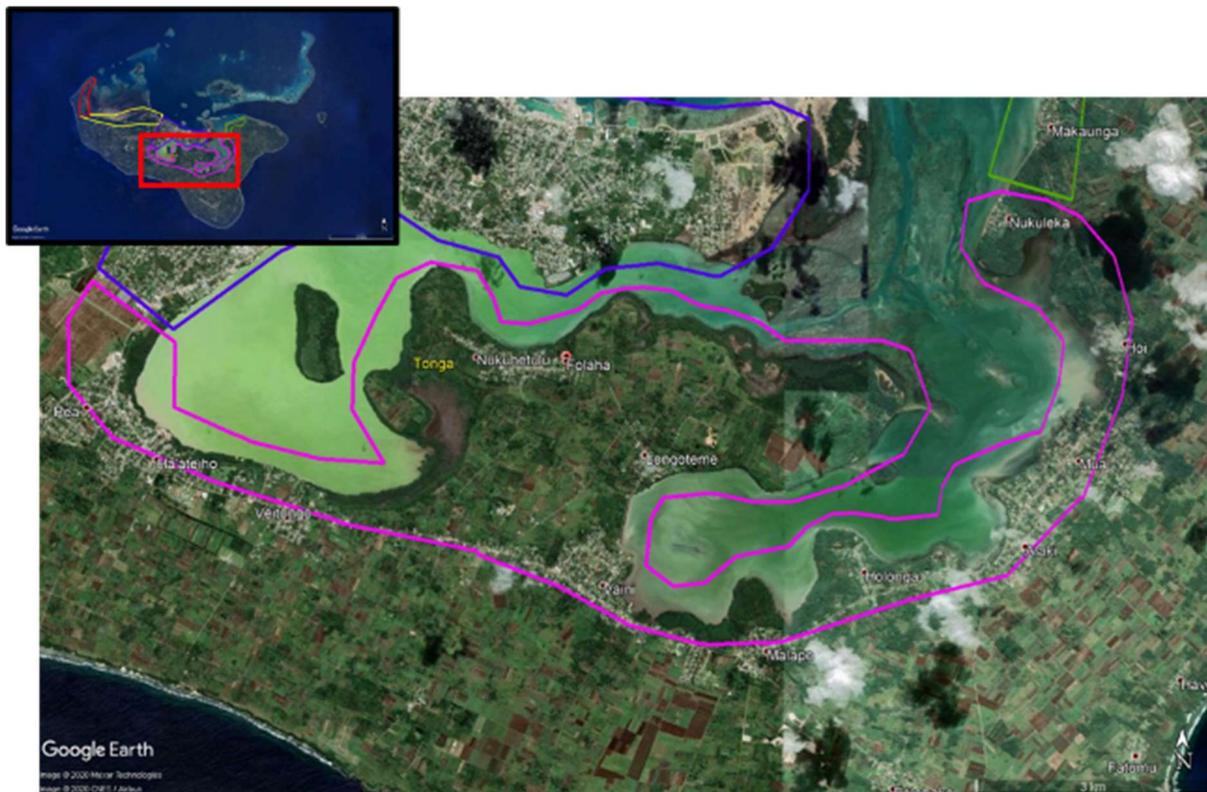
Figure 8.1 Location map of coastal unit 4 (magenta line) along the southern shores of the Fanga'uta Lagoon, Tongatapu between Nuku'alofa and Nukuleka (Image sourced from Google Earth, 2020).

Coastal unit 4 between Nuku'alofa and Nukuleka comprises the southern shores of the Fanga'uta Lagoon (Figure 8.1). In contrast to the northern shores (Nuku'alofa), the southern shores are significantly less developed with considerable mangrove stands existing. The Pe'a and Folaha Sectors (northern arm of the lagoon) are more low lying than the Vaini and Mua Sectors to the south (see Figure 8.9 for lagoon sectors) and are thus more susceptible to inundation and flooding (Figure 8.2). The southern shores of the lagoon are not subject to large incident wave conditions due to the low energy nature of the environment and small fetch of the lagoon. Thus, coastal protection structures along the southern shore of the Fanga'uta Lagoon are effectively non-existent and little change has occurred except for mangrove removal. If mangroves were to be entirely removed, then coastal erosion would be more evident than it is currently.

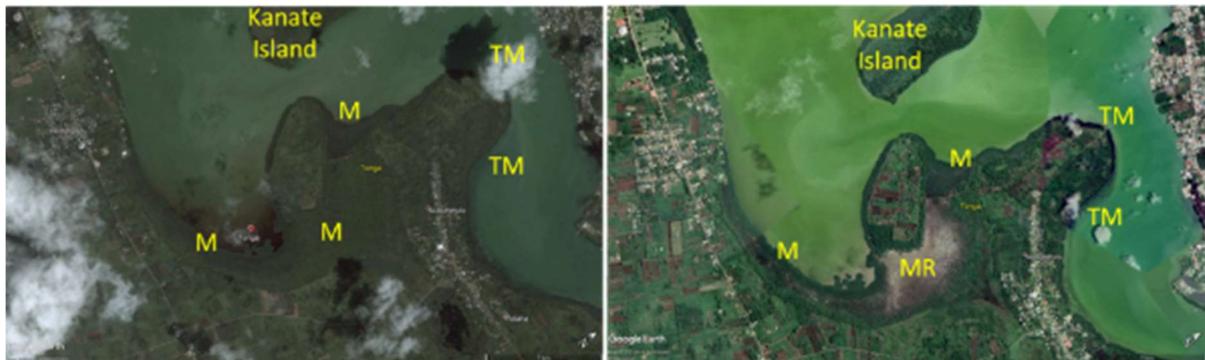
Figure 8.4 Image shows nearshore and shoreline bio-physical features between Veitongo and Nukuhetulu villages, Tongatapu, Kingdom of Tonga (Image sourced from Google Earth, 2020). Left – Image from 09/03/2002 showing little mangrove removal. Right – Image from 17/06/2020 showing substantial mangrove removal. Note: M = mangroves, TM = thin mangroves, and MR = mangrove removal.

The shoreline between Veitongo and Nukuhetulu is characterised by an unbroken mangrove stand, which varies in thickness due to mangrove removal. A large section of mangroves has been removed (~0.42 km²) just south from Nukutehulu village (Figure 8.4). The mangroves become thin along the Nukuhetulu shoreline, which is most likely a result of the higher energy experience along this section, as well as the greater water depths limiting sediment accumulation. The topography of the area is a combination of low-lying mangrove hotspots (< 1 m) and high ground comprising headlands and Nukuhetulu village (>2 but <3 m). Folaha village is slightly lower between 1 and 2 m above present coastline levels (Figure 4.14).

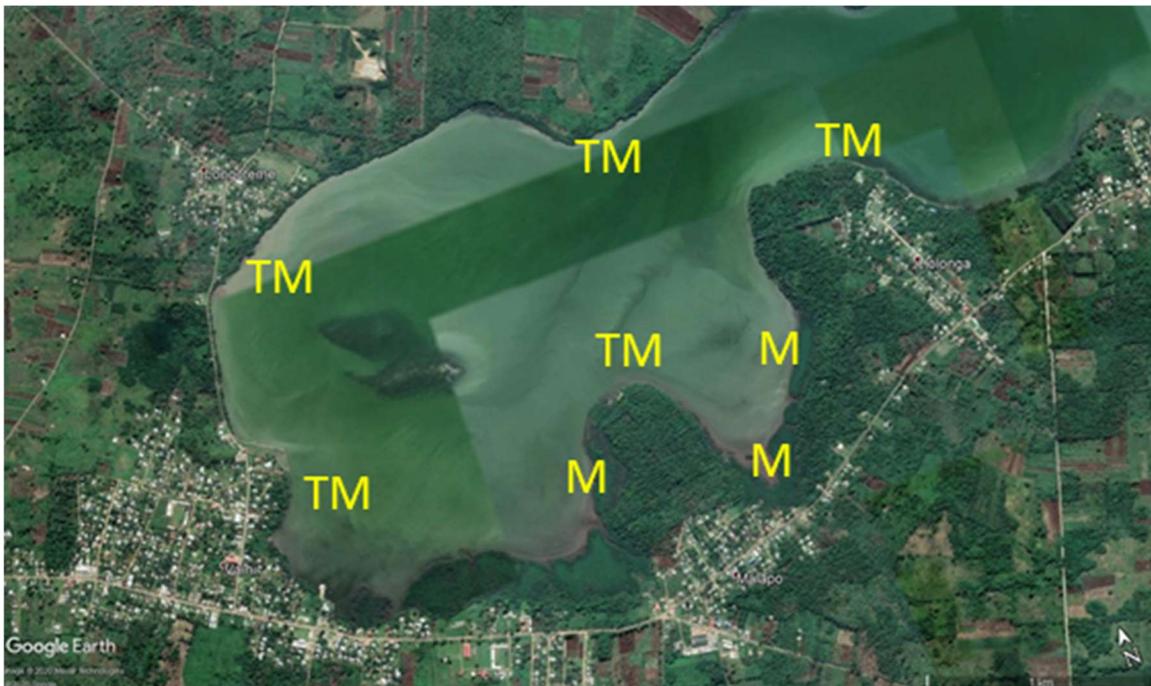
Figure 8.6 Image shows nearshore and shoreline bio-physical features between Longoteme and Holonga villages, Tongatapu, Kingdom of Tonga (Image sourced from Google Earth, 2020). Note: M = mangroves, and TM = thin mangroves.

The shoreline between Longoteme and Holonga is characterised by urban development encroaching on the shoreline (Figure 8.6). Pockets of mangroves occupy the space between villages and lowland areas, while headlands are characterised by thin mangrove stands. The largest mangrove pocket lies westward of Malapo village at ~340 m wide. The nearshore environment is shallow (1 to 2 m depth) and sheltered from prevailing winds. Hence, mangroves. Vaini has is somewhat low-lying (2 and 3 m), with Malapo and Holonga situated at >4 m above present coastline levels (Figure 4.14).

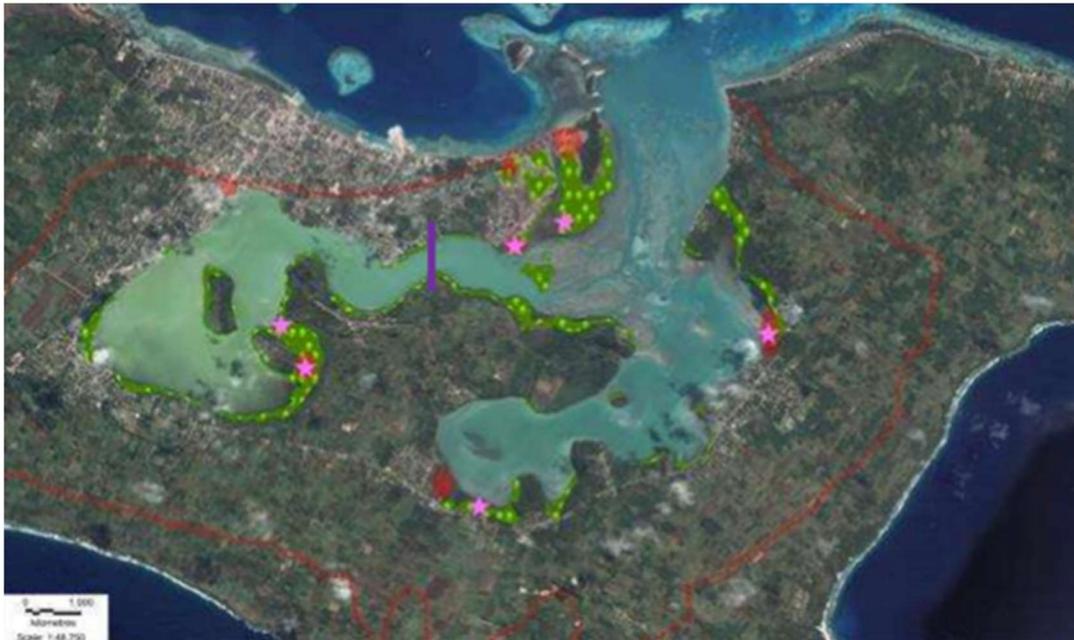
Figure 8.10 Shows areas identified as having mangroves around the lagoon. Pink stars show the locations of the monitoring sites, red areas are mangrove hotspots (damaged areas) and green areas are mangrove cover. Note the purple line delineates the approximate location of the proposed new bridge. The red line delineates the catchment boundary (modified from Talia'uli *et al.*, 2016).

As part of the Ridge to Reef Project in 2014, a baseline survey was carried out which identified mangrove hotspots (damaged areas) and non-hotspot areas (undamaged). The results of the baseline survey are shown in Figure 8.10 which indicates that where the proposed lagoon bridge is to be constructed (purple line) the mangroves are somewhat healthy. Note this data is from 2015. Figure 8.11 and Figure 8.12 (NBSAP, 2014) provide an alternative interpretation. These maps indicate that the mangroves within this area have been removed and the lands reclaimed on the northern side where the proposed bridge is to be constructed. NBSAP (2014)

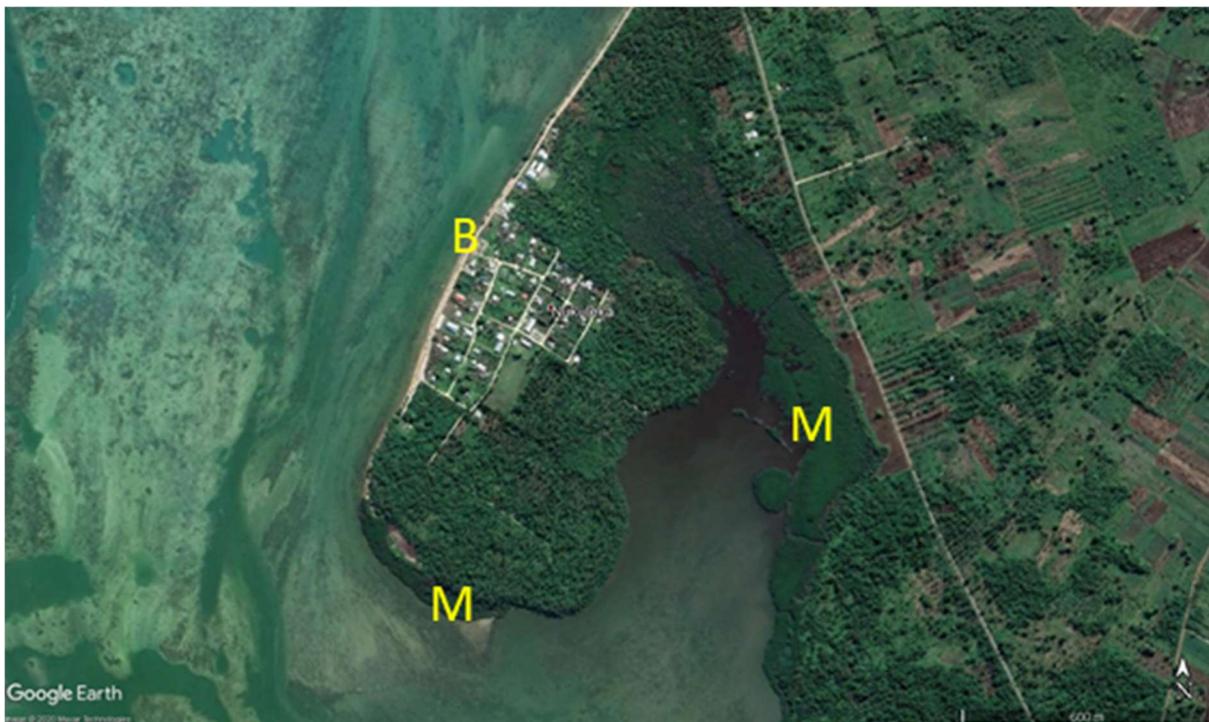
The village of Nukuleka lies on the eastern side of the Fanga'uta Lagoon entrance. The nearshore is comprised of shallow sandy sediments with the shoreline of the village consisting of a thin beach. Along the southern tip, a small mangrove stand exists ~450 m long by 50 m wide with mangroves also located along the northern and eastern sides of the small inlet ~1.5 km long and 210 m at its widest (Figure 9.3). The existence of the sandy beach and the mangroves indicates the different energies within these environments with the sandy beach indicative of higher energies (due to the channel) and the mangroves indicative of low energies within the inlet.

Figure 9.3 Image shows nearshore and shoreline bio-physical features of Nukuleka village of coastal unit 5, Tongatapu, Kingdom of Tonga (Image sourced from Google Earth, 2020). Note: M = mangroves and B = beach.

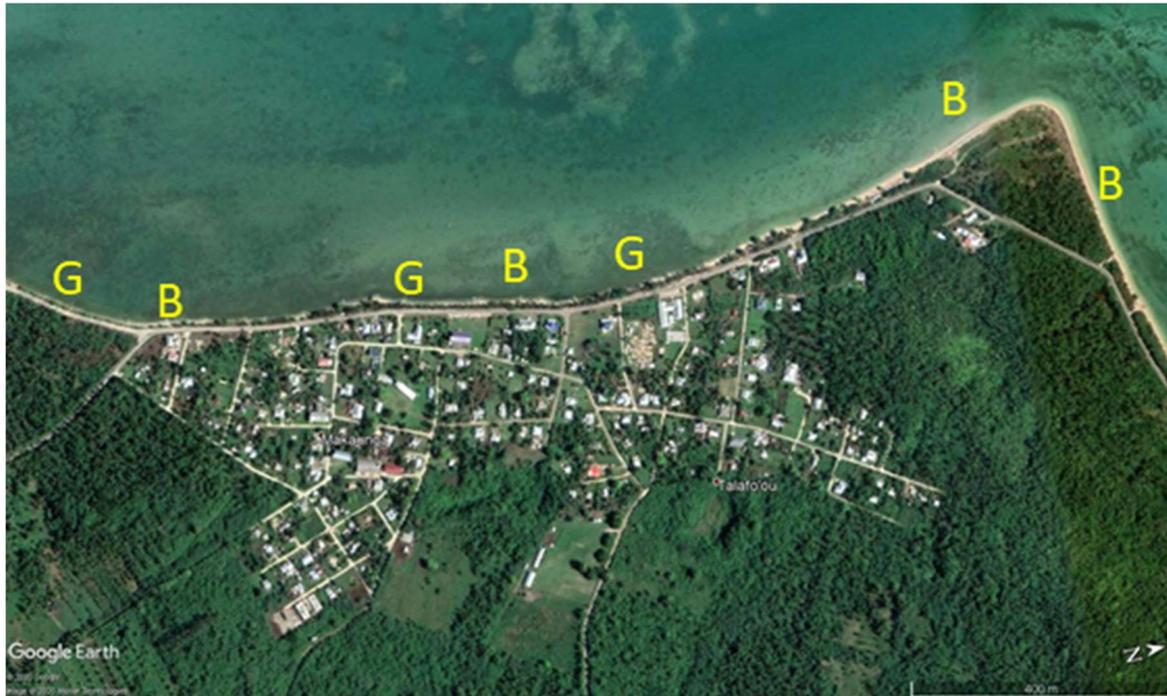
Northward toward the Fanga'uta Lagoon entrance, the nearshore environment of Makaunga and Talafo'ou villages again comprises shallow sandy sediments within the channel with a thin beach system extending to the lagoon entrance (Figure 9.4). The beach system is thinnest southward and thickens toward the entrance. A groyne field has been constructed along this section of coastline to trap sediment and grow the beach system (Figure 9.5 and Figure 9.6). Mead (2019b) carried out a performance evaluation of the eastern Tongatapu climate change resilience trial constructions, which included an inspection of the mentioned groyne field. The findings were that:

Figure 9.4 Image shows nearshore and shoreline bio-physical features of Makaunga and Talafo'ou villages of coastal unit 5, Tongatapu, Kingdom of Tonga (Image sourced from Google Earth, 2020). Note: G = Groynes, B = beach

Mead (2019) made recommendations to:

- *Fill the gaps of 60 and 120 m spacing to have groynes at 30 m intervals along the beach;*
- *Use the half open configuration for all additional groynes;*
- *Rotate the half open units at the 6 southern groynes to be fully closed, and;*
- *Bring in an additional 3,000 m³ of sand from the sand collection area to distribute in the areas of the additional groynes, and the southern areas of the site where none has yet been placed.*

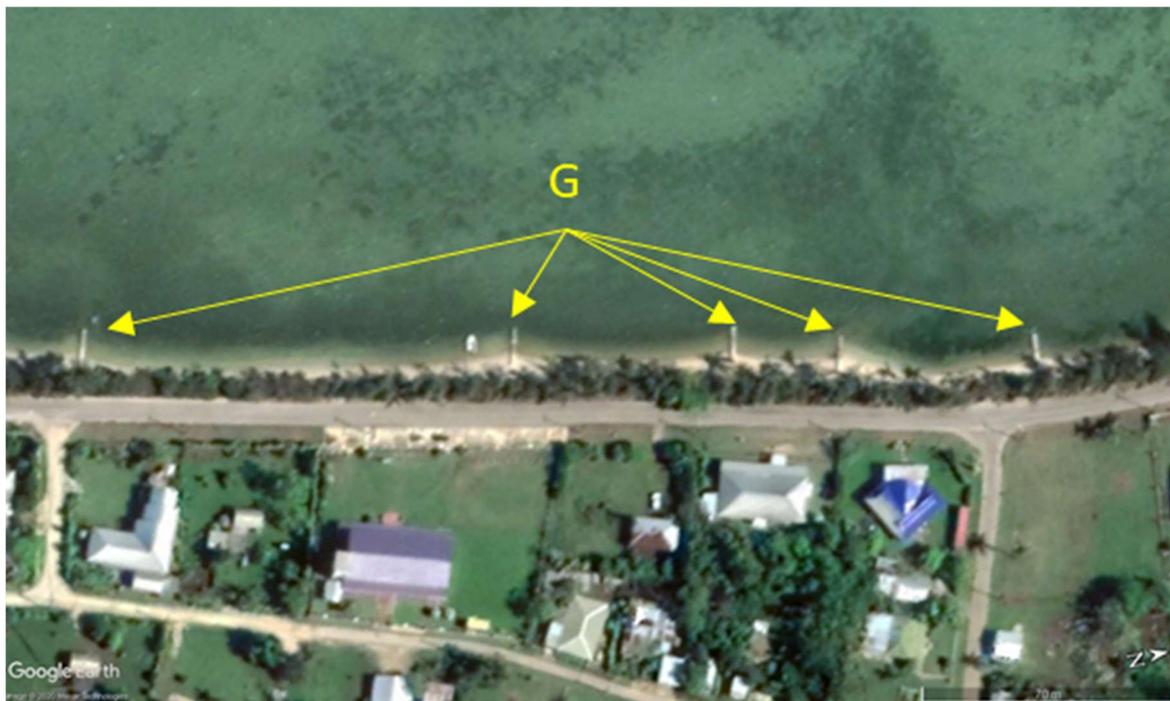
Figure 9.5 Image shows groynes along the coastline adjacent to Makaunga and Talafo'ou villages of coastal unit 5, Tongatapu, Kingdom of Tonga (Image sourced from Google Earth, 2020). Note: G = Groynes.

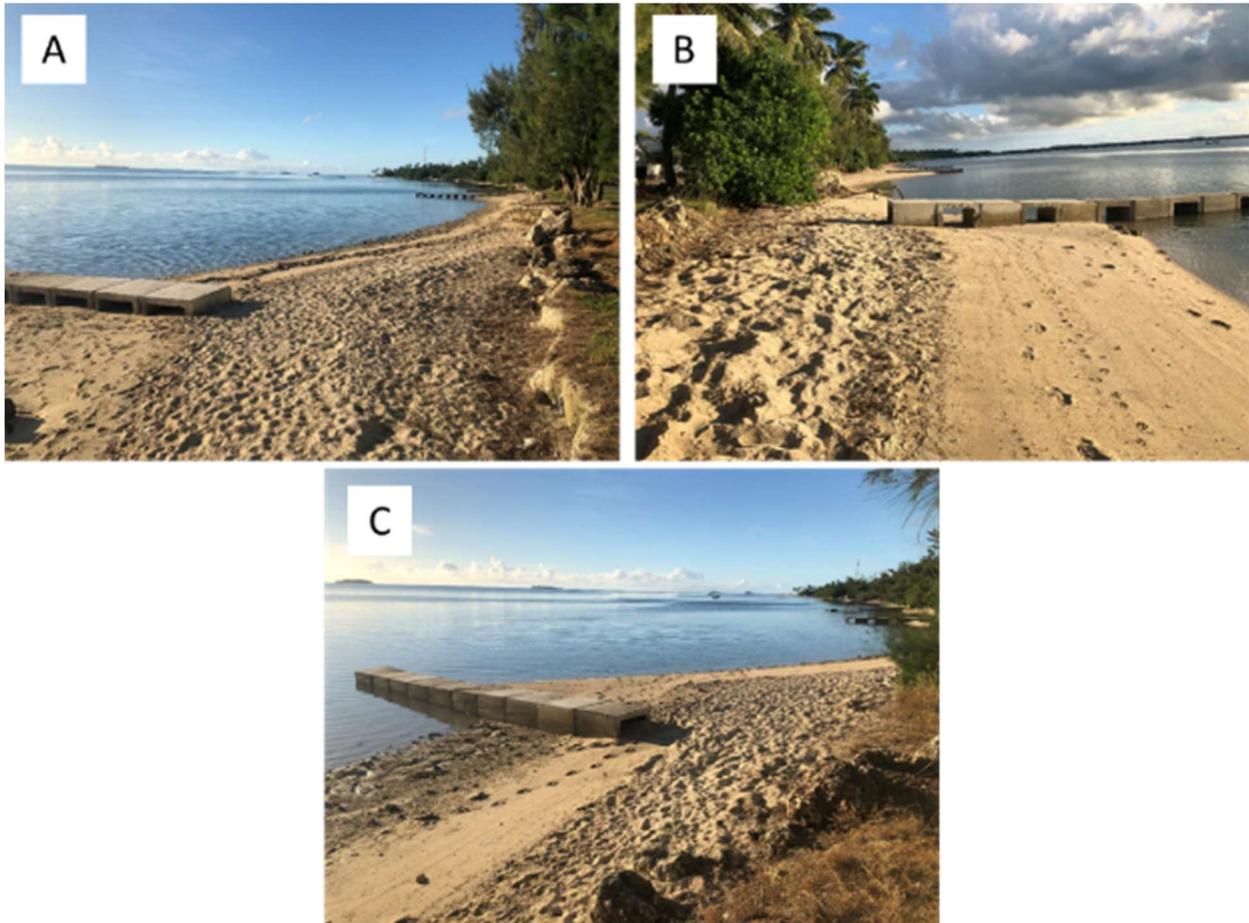
Figure 9.6 Image shows the three types of groyne that have been constructed on the beaches adjacent to Makaunga and Talafo'ou villages. A) fully open, B) half-open, and C) closed.

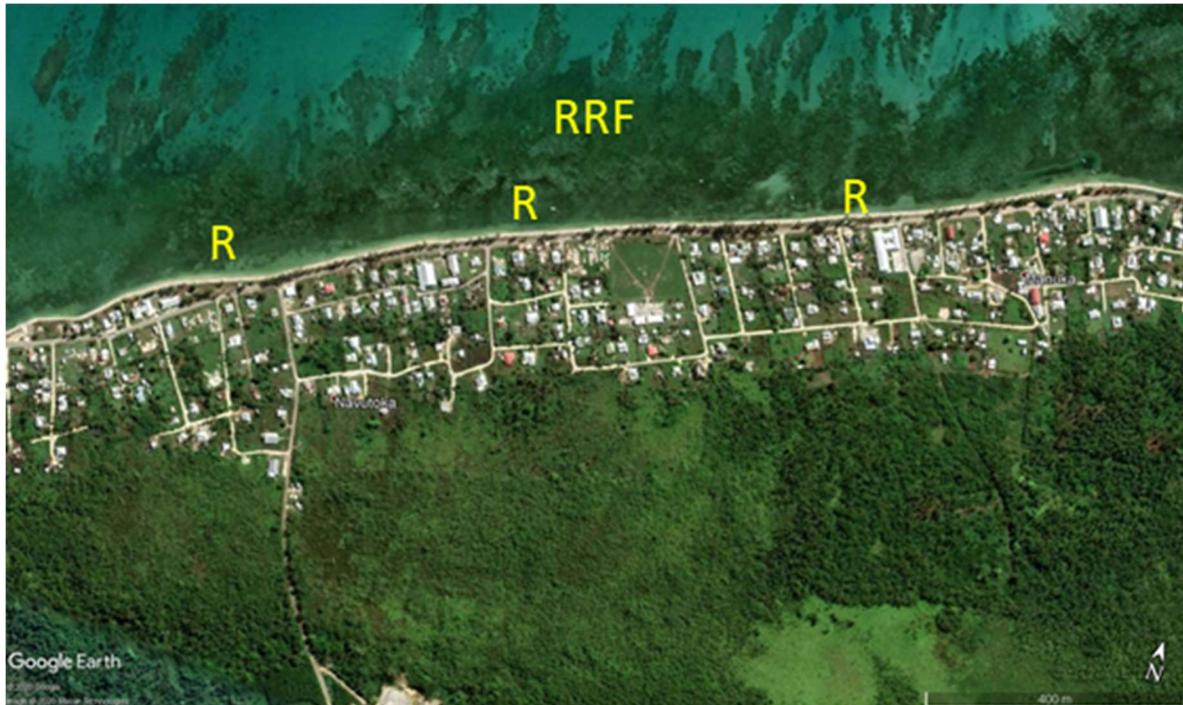
East of the Fanga'uta Lagoon entrance are Navutoka and Manuka villages, the nearshore of which comprises intertidal reef flats with the shoreline characterised by a 2 km long breakwater/revetment (Figure 9.7, Figure 9.8, and Figure 9.9). At the eastern end of Manuka village is a series of detached breakwaters (Figure 9.10). This section of coastal unit 5 is far more exposed than the villages along the eastern side of the lagoon entrance but is still protected from the predominant south-east winds and swells. Cyclones from the north do, however, produce large waves which can penetrate this section of the coastline. Hence, the need for coastal protection structures which have been trialled.

Figure 9.7 Image shows revetment/breakwater along the coastline adjacent to Navutoka and Manuka villages of coastal unit 5, Tongatapu, Kingdom of Tonga (Image sourced from Google Earth, 2020). Note: R = revetment/breakwater and RRF = rocky reef flats.

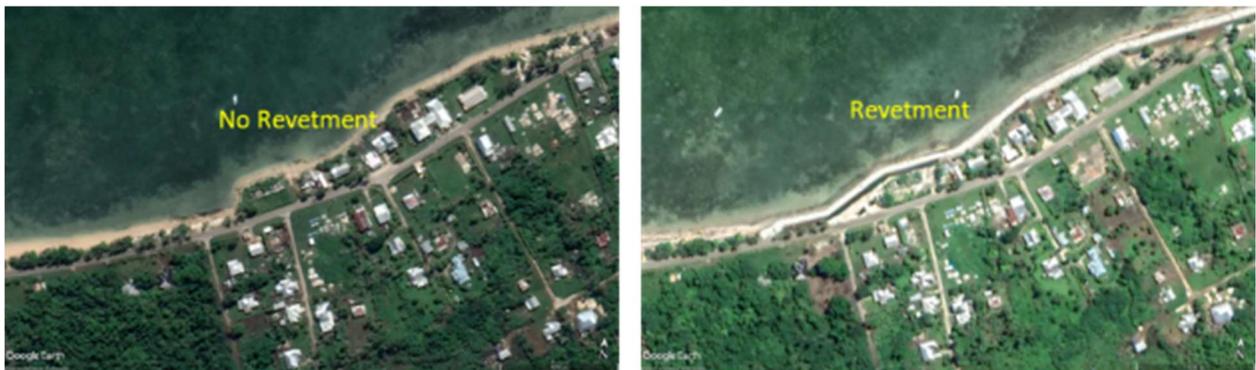
Figure 9.8 Left - Image shows original coastline (29/05/2018). Right – Image shows constructed revetment/breakwater along the coastline (2/05/2019) adjacent to Navutoka and Manuka villages of coastal unit 5, Tongatapu, Kingdom of Tonga (Image sourced from Google Earth, 2020).

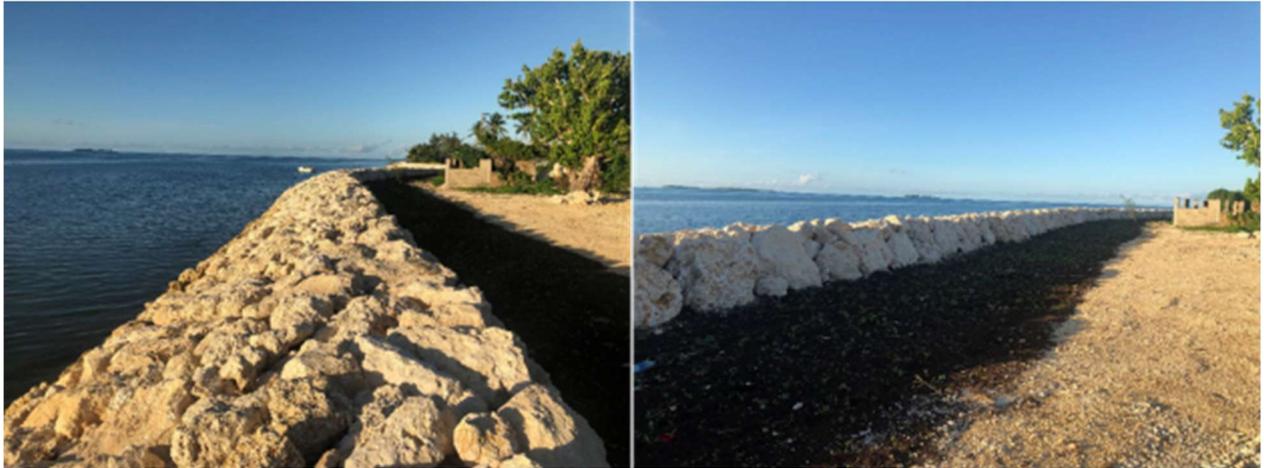
Mead (2019b) carried out an inspection of the detached breakwaters and reported that they have been extremely effective at widening the beach to provide a buffer zone and stop overtopping on to the coastal road, which normally overtops 2-3 times year during storm events. Mead (2019b) reported that there is now 10-30 m of buffer zone and that a series of crescent shaped beaches have been produced (Figure 9.10). The trial proved that detached

Figure 9.9 Images show revetment/ breakwater along the coastline in front of Navutoka and Manuka villages of coastal unit 5, Tongatapu, Kingdom of Tonga (Images sourced from Mead, 2019b).

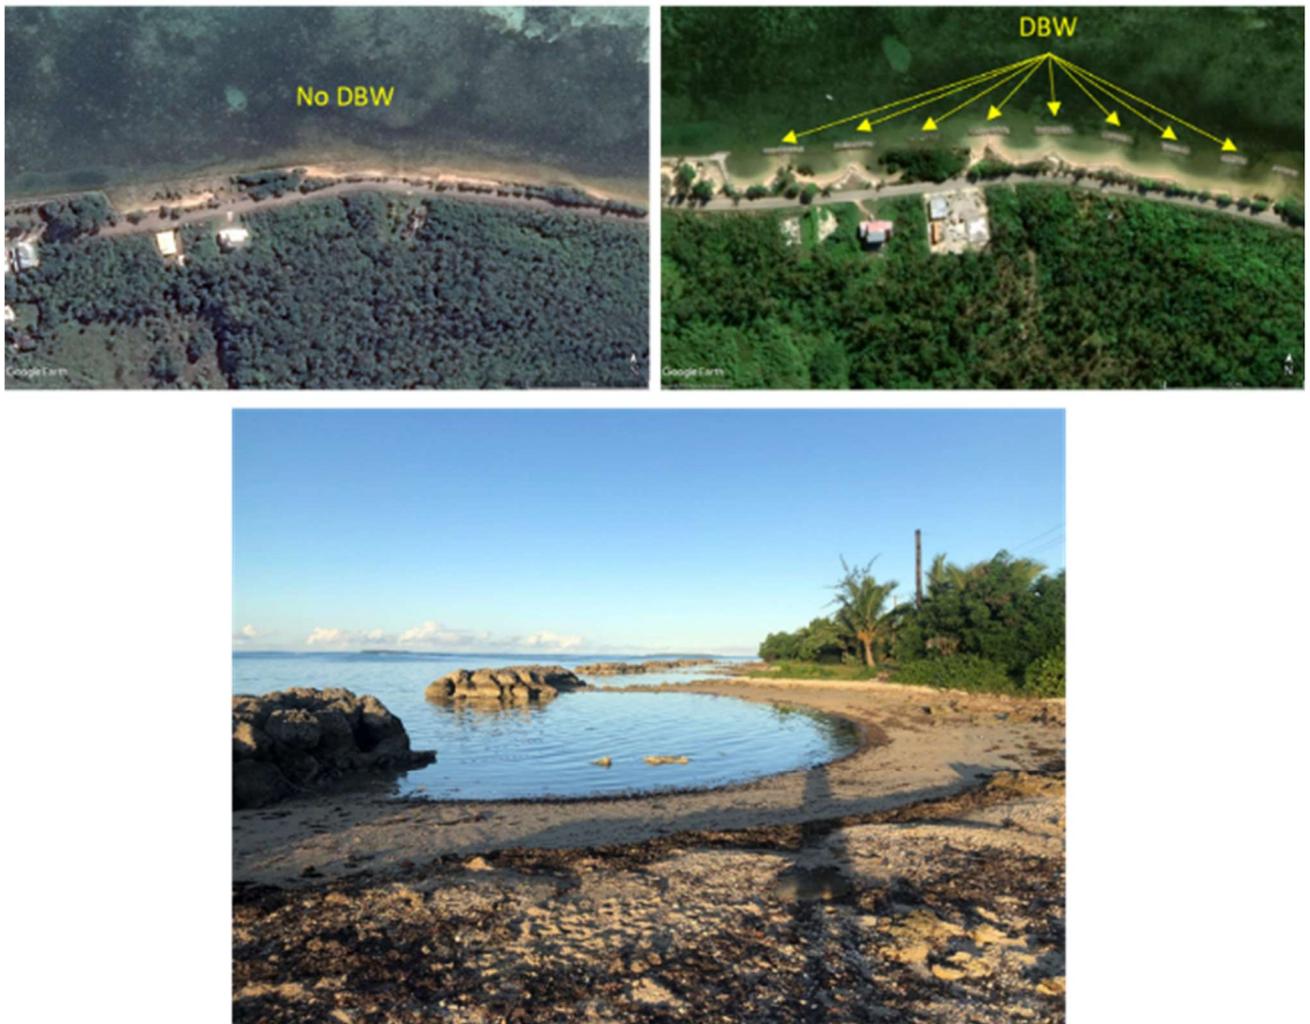
Figure 9.10 Left – Image shows no detached breakwater series (18/07/2014). Right and Bottom - Images show detached breakwater series along the same stretch of coastline at the eastern end of Manuka Village of coastal unit 5, Tongatapu, Kingdom of Tonga (Image sourced from Google Earth, 2020 and Mead, 2019b). Note: DBW = detached breakwater.

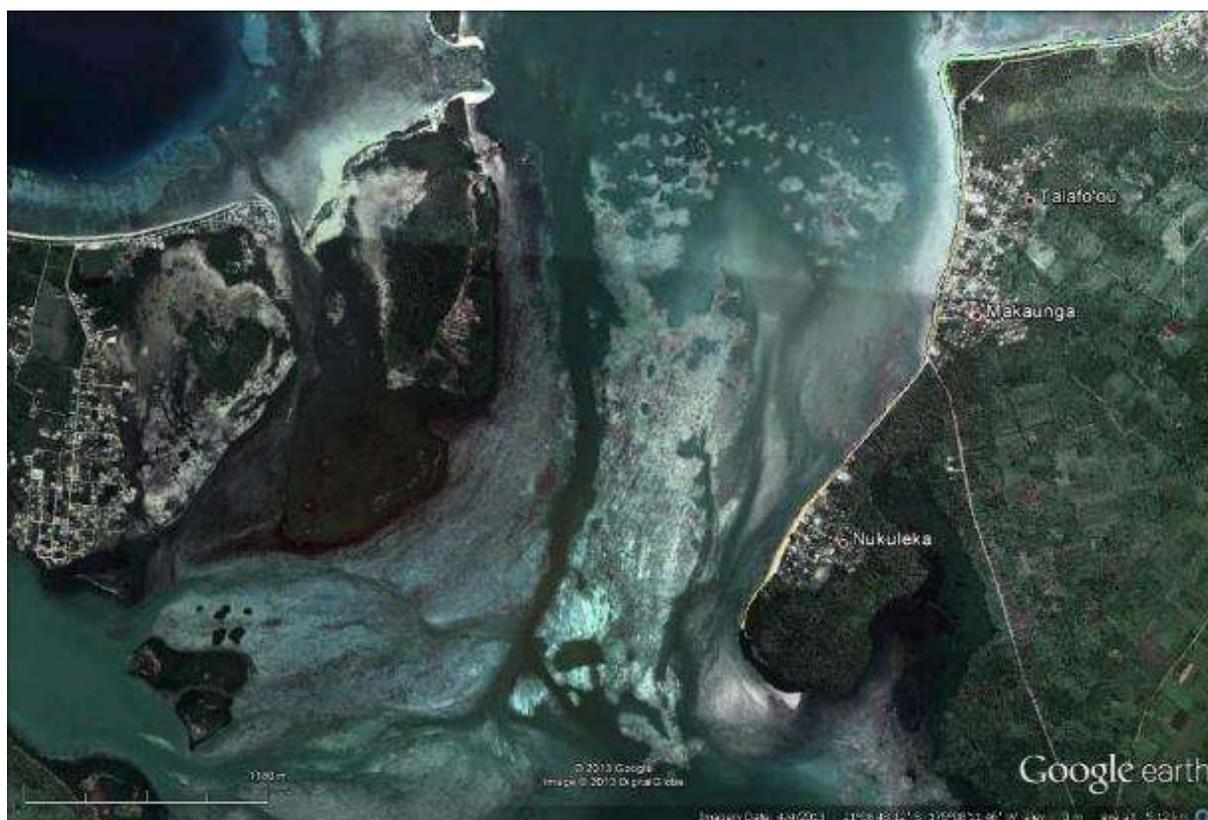
Unfortunately, only the 2011 aerial photograph covers Nukuleka village, so no comparisons or historic shoreline positions could be made. This is unfortunate, since discussions with local people indicated that this area previously had a mangrove fringe and the beach was some 20-30 m further seaward. Indeed, it is likely that this whole western side of the study site had a mangrove fringe of this width, due to the low wave exposure and the existing mangrove fringe on the opposite side of the lagoon entrance (Figure 9.11 and Figure 9.12).

Figure 9.11 The entrance to the Fanga'uta lagoon. A mangrove strip is evident on the unpopulated western side, while it is absent on the eastern side where the villages are – this is more evident in Figure 9.12 below (Mead *et al.*, 2013).

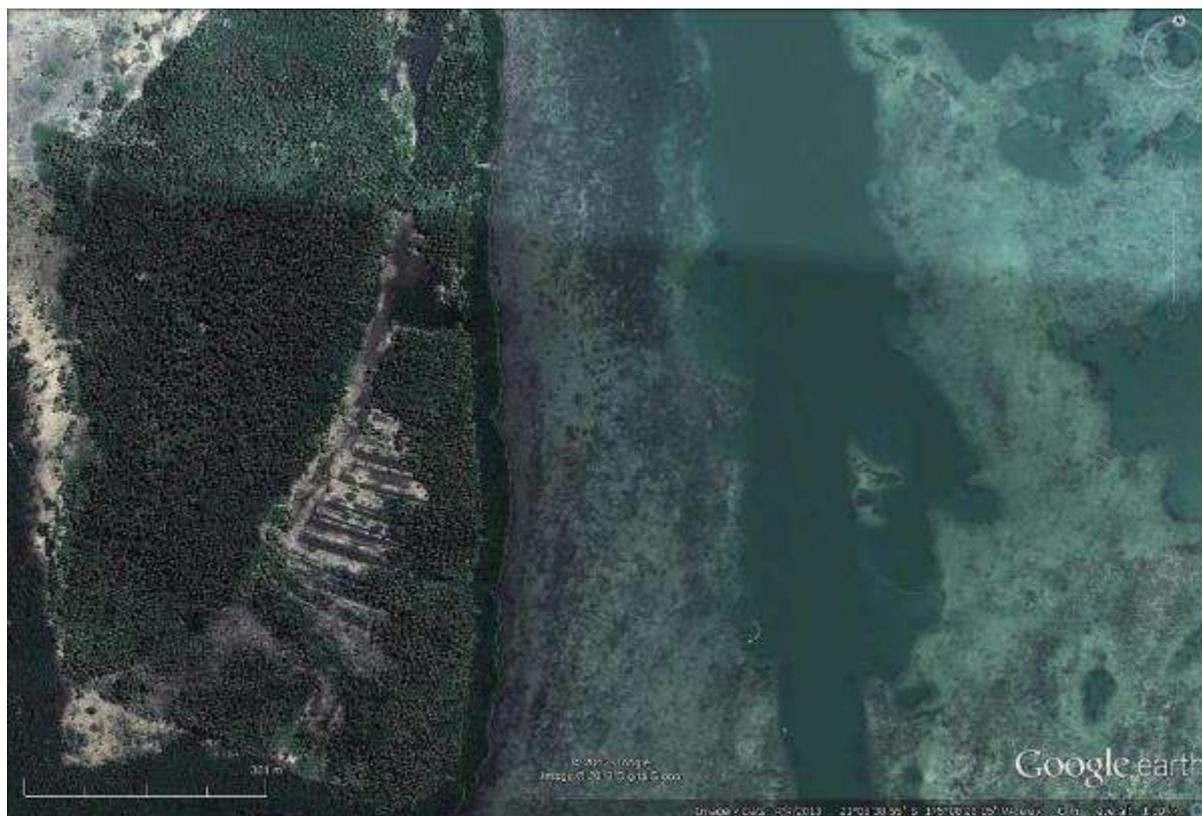
Figure 9.12 The western side of the lagoon entrance (top) has a 20-40 m wide mangrove fringe, which is absent on the eastern side (bottom), except on the southern tip of the peninsula below (Mead *et al.*, 2013).

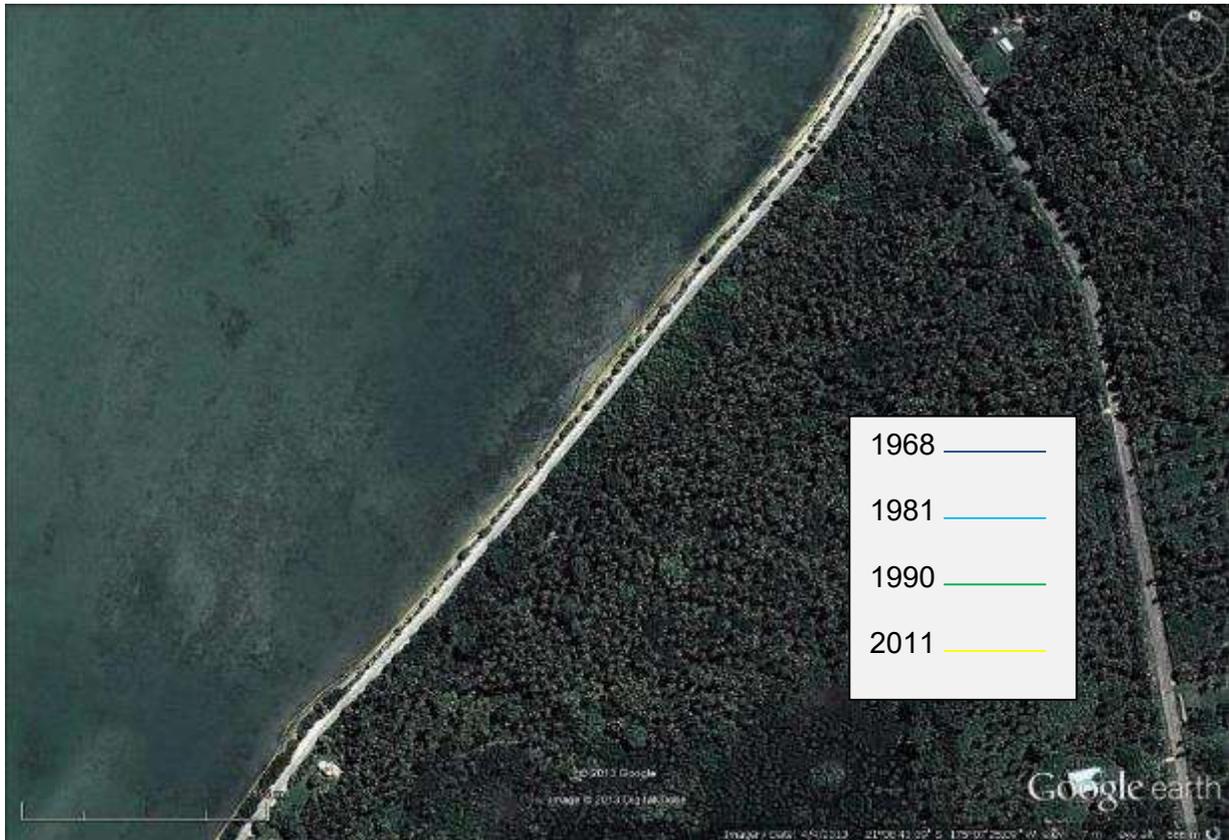
Figure 9.13 Beach position between 1968 and 2011 (1981 and 1990 aerials do not cover this area) below (Mead *et al.*, 2013).

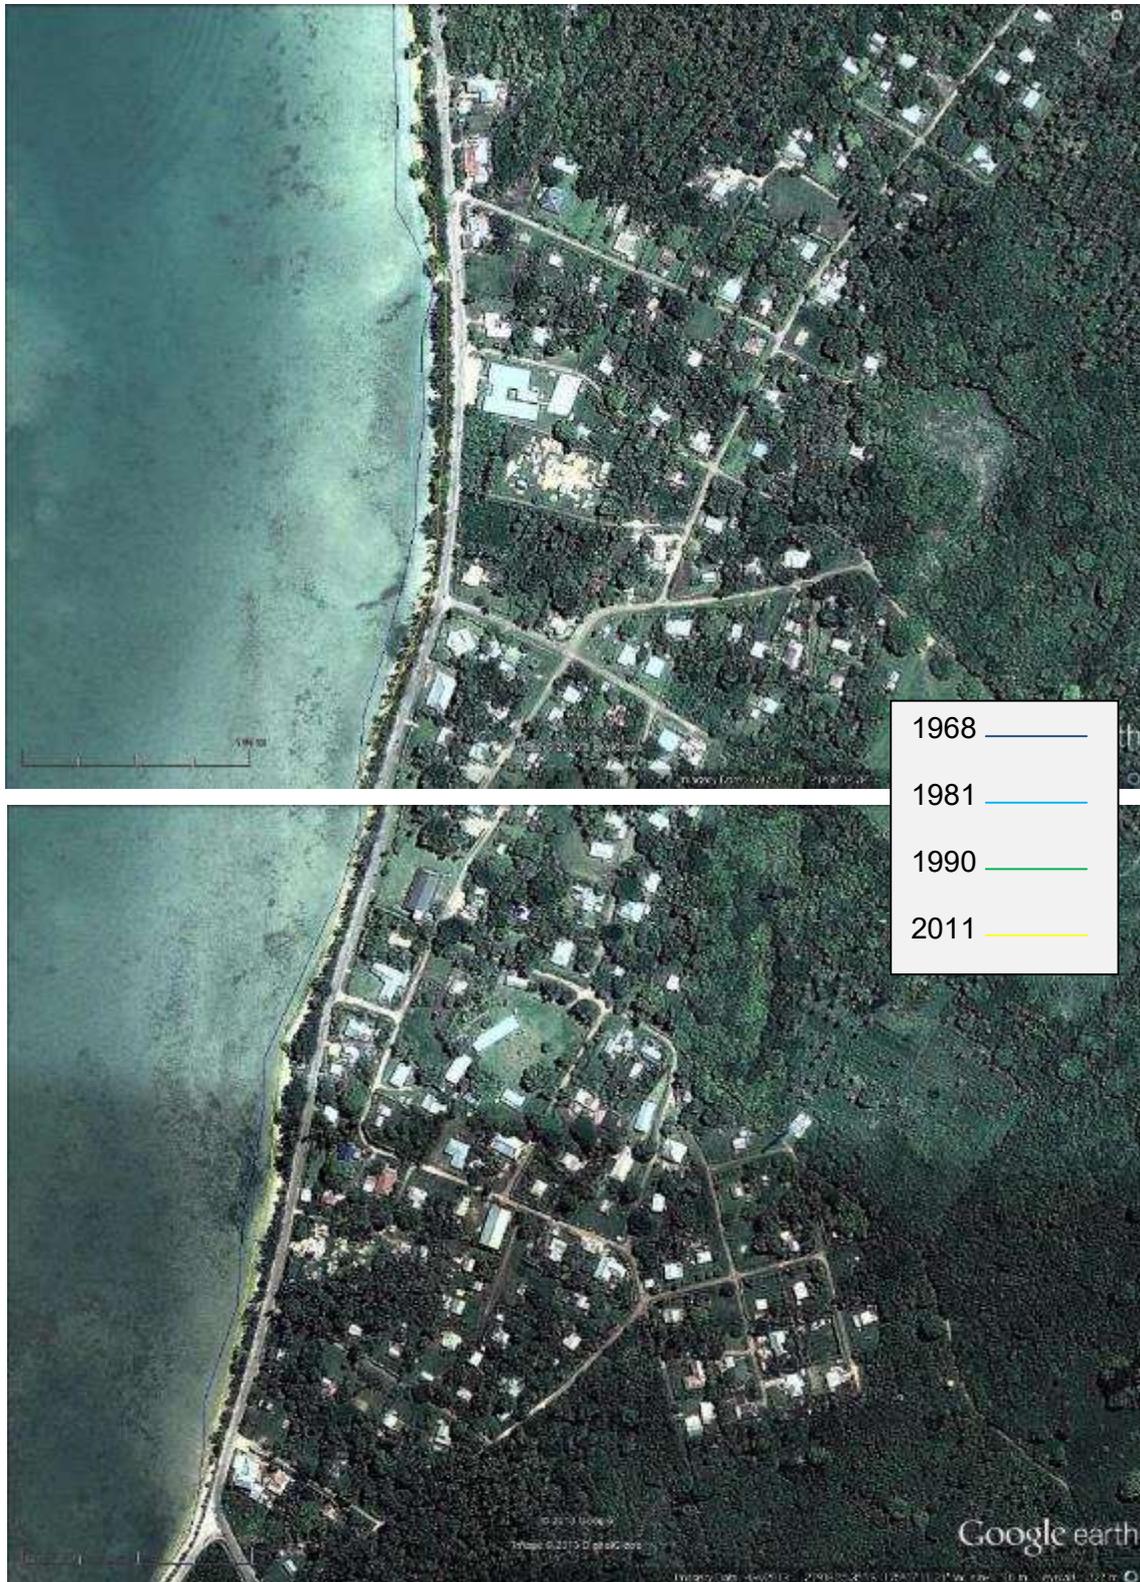
Figure 9.14 Beach position along Makaunga/Talafo'ou villages between 1968 and 2011 below (Mead *et al.*, 2013).

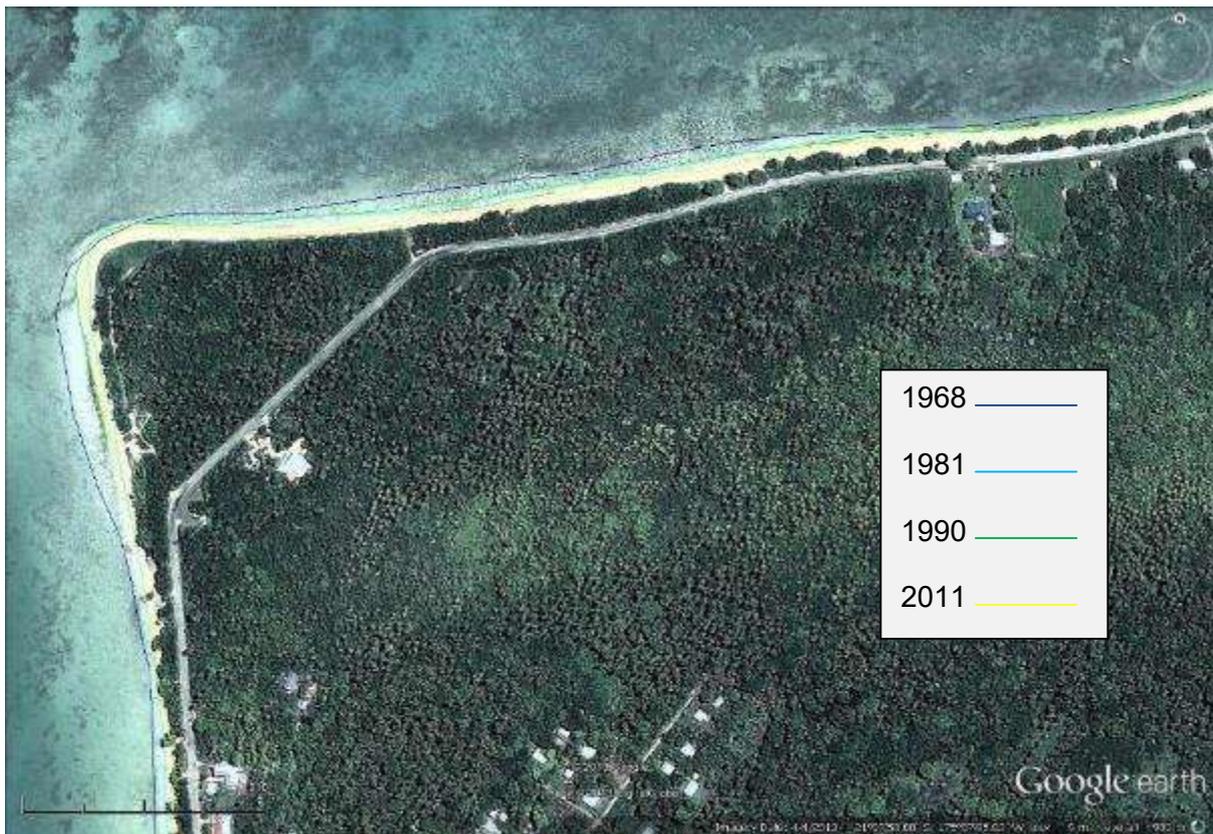
Figure 9.15 Beach position between Makaunga/Talafo'ou and Navutoka villages between 1968 and 2011 below (Mead *et al.*, 2013).

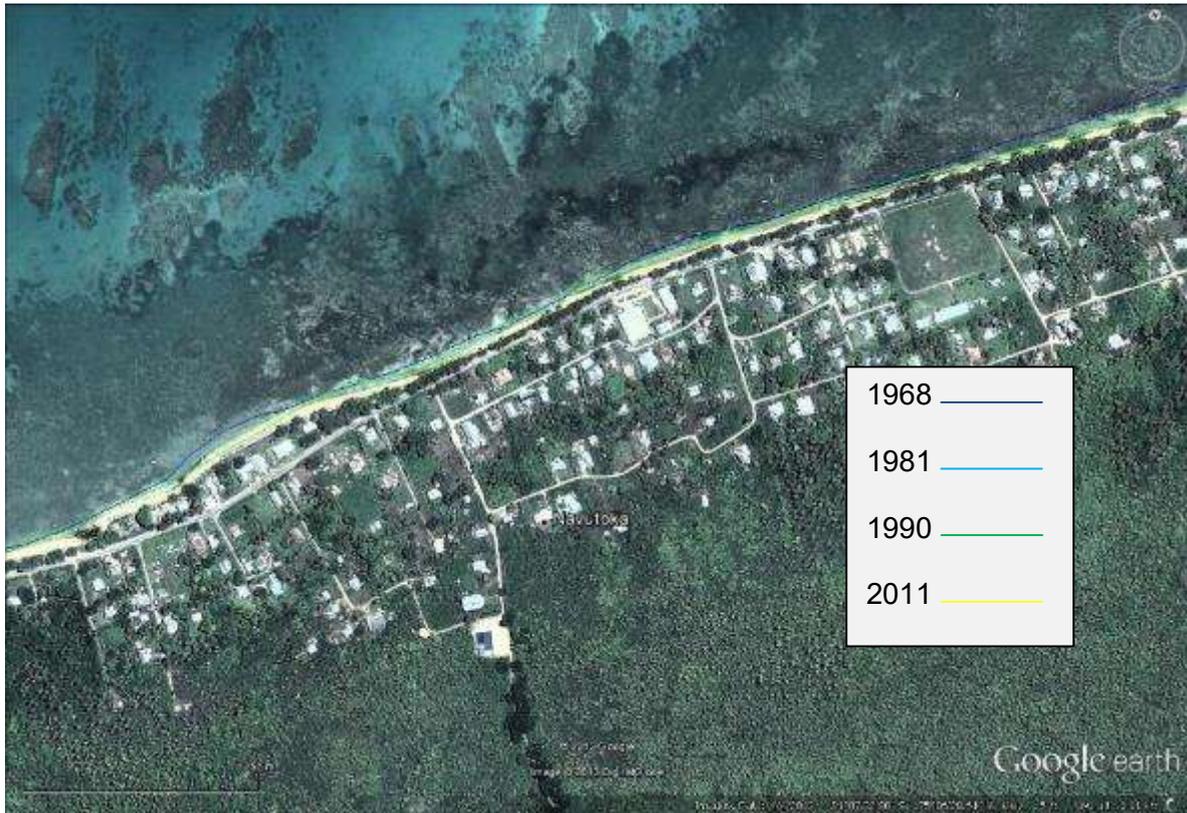
Figure 9.16 Beach position along Navutoka Village between 1968 and 2011 below (Mead *et al.*, 2013).

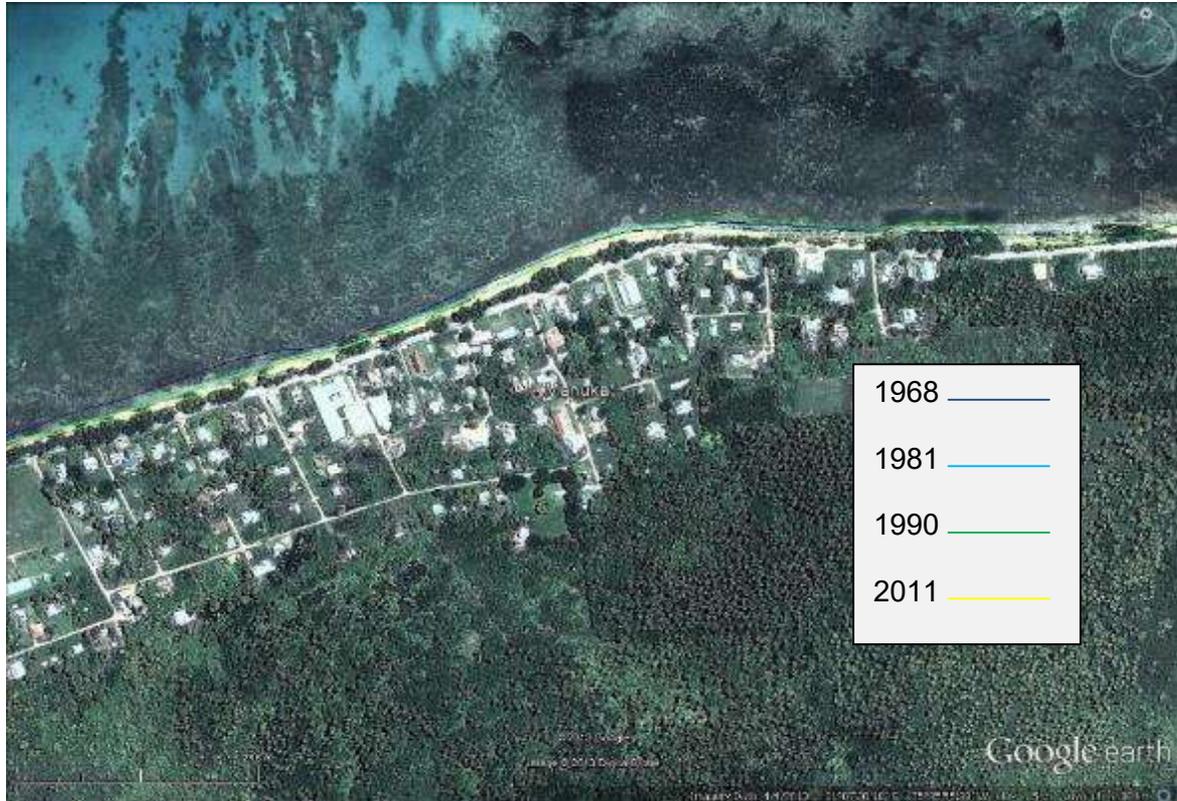
Figure 9.17 Beach Position along the beach at Manuka Village between 1968 and 2011 below (Mead *et al.*, 2013).

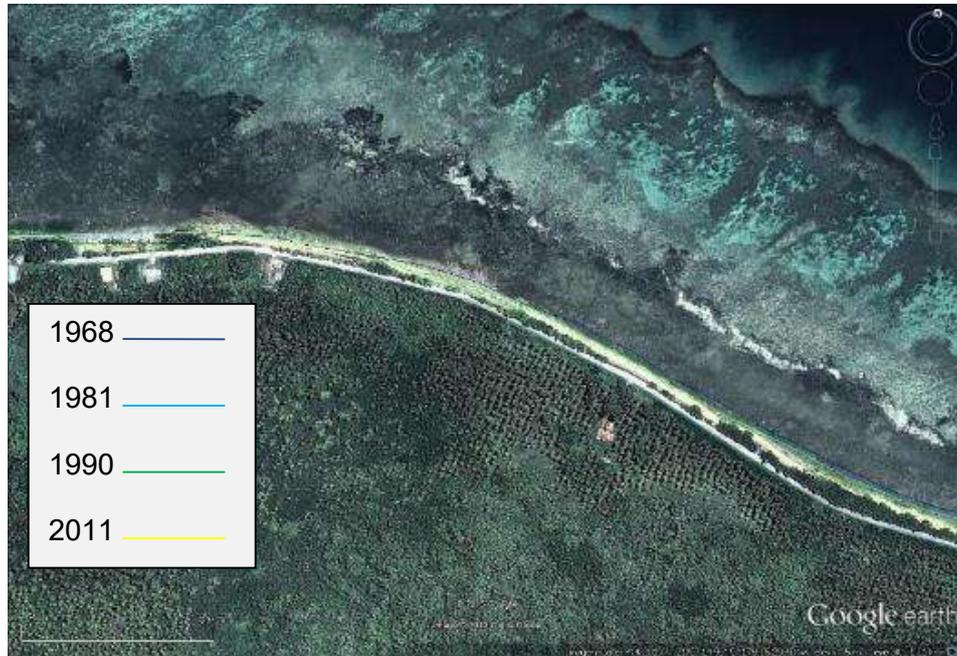
Between Manuka and Kolonga Villages, the beach has retreated between 5 and 15 m since 1968 (Figure 9.18 and Figure 9.19). To the west, the greatest retreat generally occurred between 1968 and 1980 (Figure 9.18), while to the east of this stretch significant retreat also occurred between 1991 and 2011 (Figure 9.19).

Figure 9.18 Beach position along the western part of the coast between Manuka and Kolonga between 1968 and 2011.

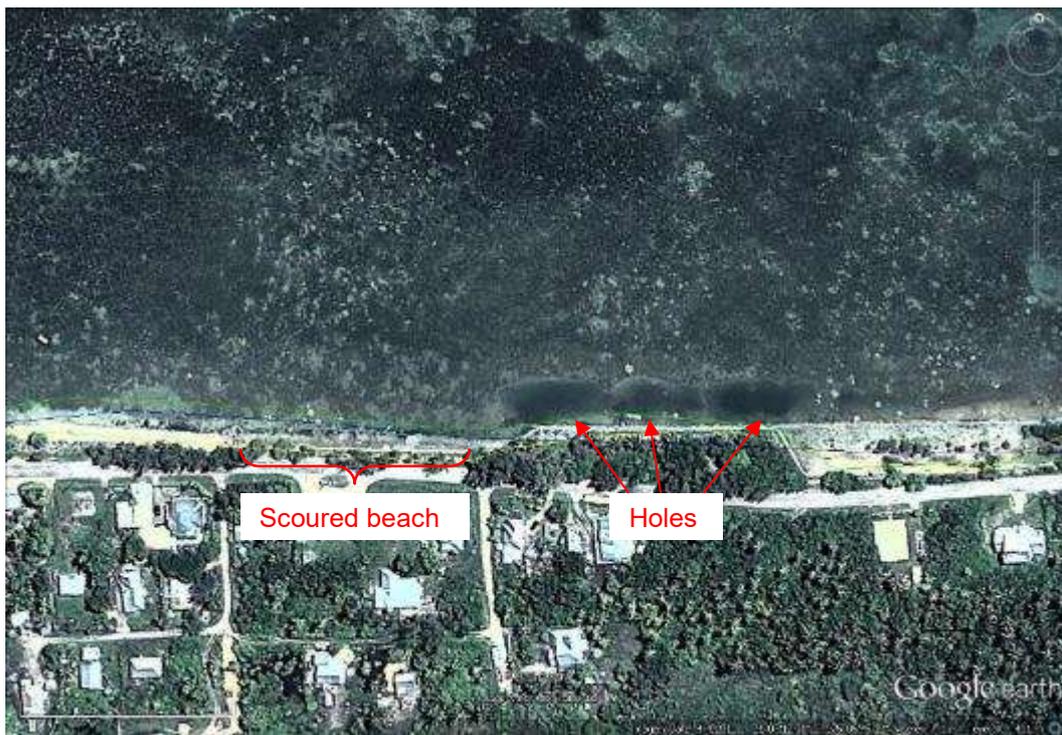
Figure 9.20. Deep holes in the nearshore zone are present at the western end of the failed seawall project, which may in part account for the adjacent scoured beach (Mead *et al.*, 2013).
