Coastal protection along the north coast of Tongatapu, Tonga (CPS 20/140) Report 1

Desktop Assessment and Community Priority Issues

Prepared for the GCCA+ SUPA Project
and the Kingdom of Tonga:

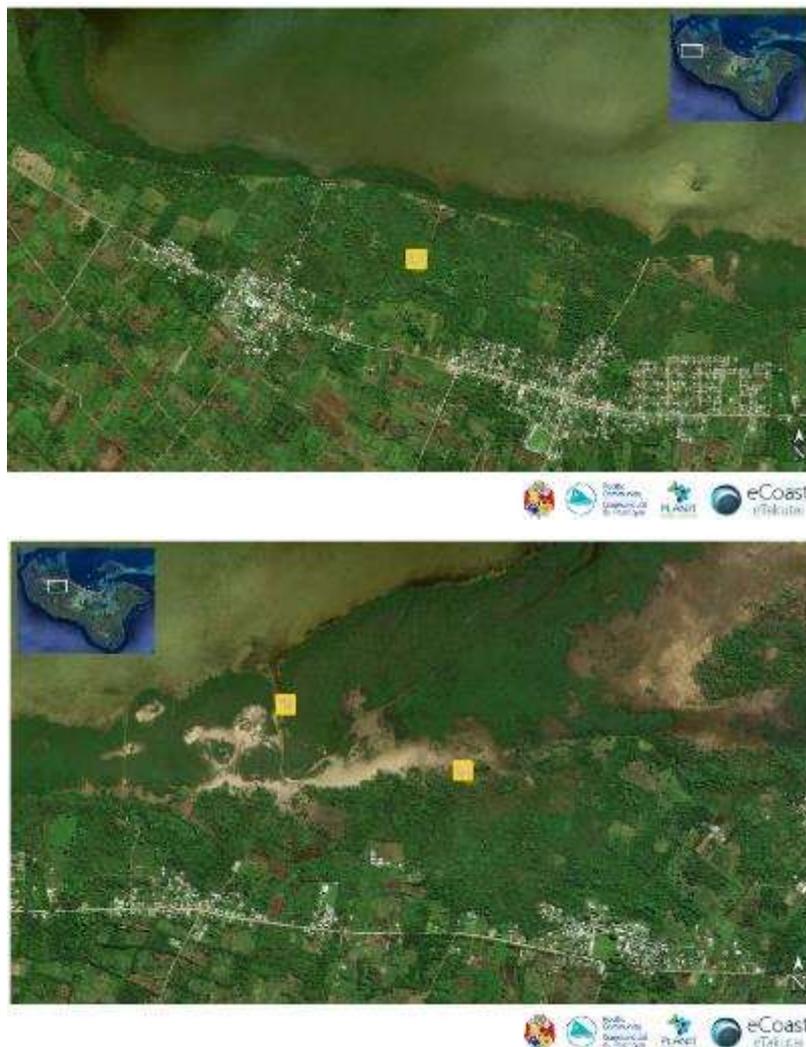
The villages in this coastal unit all report issues with inundation during heavy rain and high tides, with many roads going under-water, which is made worse with spring tides and onshore winds. It is low-lying with variable land heights, with some higher land nearer the sea than those further inland, and so it cannot drain following inundation (Figure 11.3). Some of the drainage area (shown in the bottom image of Figure 11.3) is currently being used for planting mangroves. Village representatives reported a preference for more mangrove planting for climate change resilience.

Figure 11.3. All of the villages in this coastal unit are low-lying with variable land heights, some higher nearer the sea than those further inland, and so they cannot drain well once flooded. The area shown in the bottom image is currently being used to be for planting mangroves.

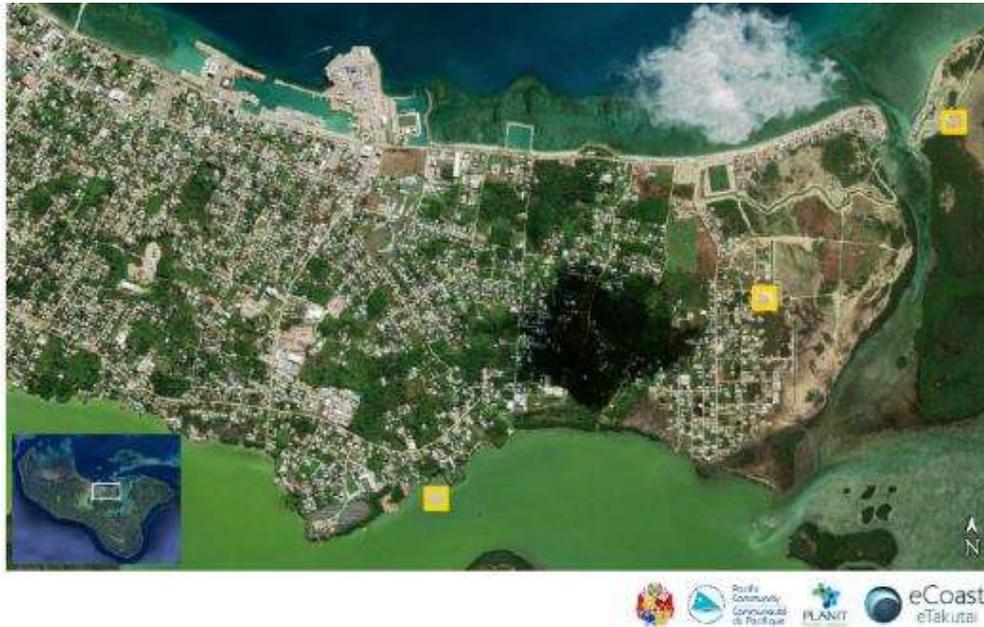
At Siesia, they have built mud/sand walls/bunds around the coast and properties (Figure 11.6). TC Harold threw lots of rocks and coral into properties, which built up and raised the properties. This is an example of coral island's keeping up with SLR (e.g., Kench *et al.*, 2015; Mead *et al.*, 2017). 50% of the seawall has been done, and the village requested help to complete it.

In Popua village at the eastern end of Nuku'alofa, the roads are higher than properties, so they flood due to heavy rain and extreme storm surge (Figure 11.6). Options put forward by the village representatives included raising the land and houses, and putting in culverts to drain water from the properties.

On the shores of the lagoon, inundation occurs because the land is very low similar to Pea and the rest of the northern lagoon coast (Figure 11.6). Reclamation is still being undertaken

Figure 11.6. At Siesia (top right), they have built mud walls around the coast and properties. TC Harold deposited a lot of rocks and coral into properties, which built up and raised the ground levels. In Popua village (middle right), the roads are higher than properties, so they flood due to heavy rain and extreme water levels. On the shores of the lagoon, there are inundation problems since the land is very low (similar to Pea and the rest of the northern lagoon coast)

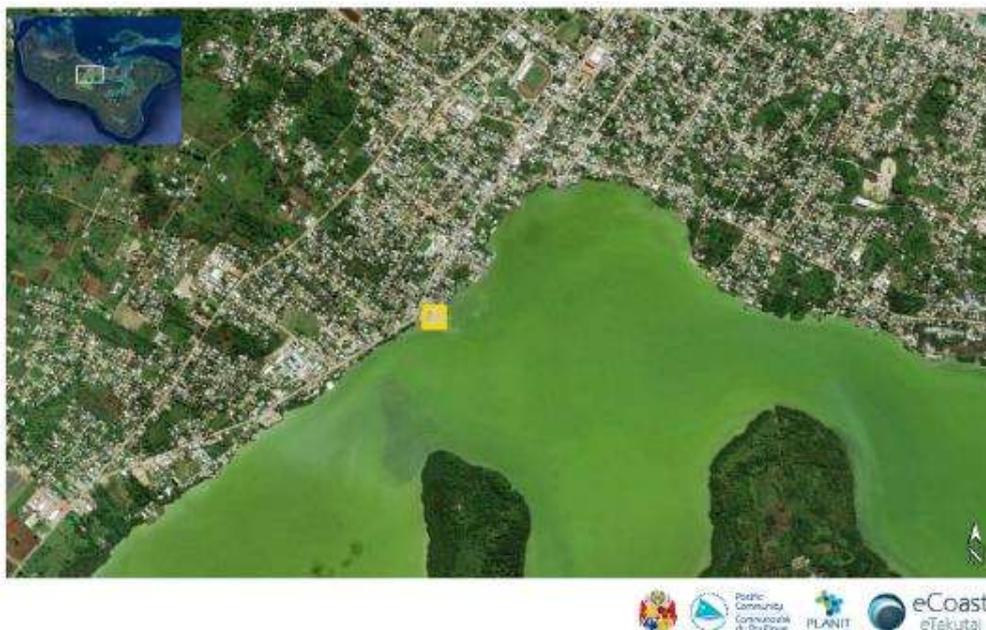
along this coast, mostly without permission and it is not being policed. This is leading to flooding issues due to the lack of drainage planning. Some claim that the land reclaimed from one area pushes water to other areas, however, this cannot happen in a water body with an open coast boundary, the water levels in the lagoon are driven by tides and metocean conditions, and so is more likely associated with SLR.

Figure 11.7. Lots of reclamation still occurring mostly without permission and it is not being policed. This is leading to flooding issues due to the lack of drainage planning.

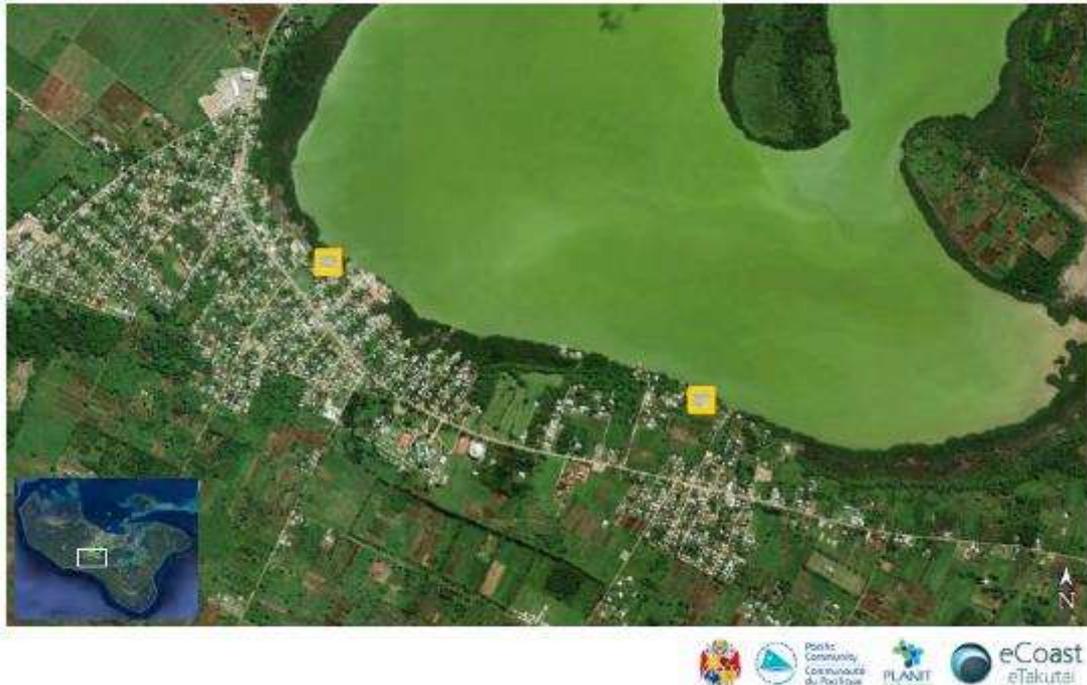
Pea to Veitongo is one of the most susceptible areas to inundation (Figure 11.8). Village representatives claim it to be lowest part of lagoon, and are concerned that reclamations lead to additional flooding. These days, the high tide comes in and floods across the road, especially during northerly winds. Similar flooding occurs to the east, although this land is not as low-lying.

Figure 11.8. Pea to Veitongo is one of the worst/lowest areas for inundation.

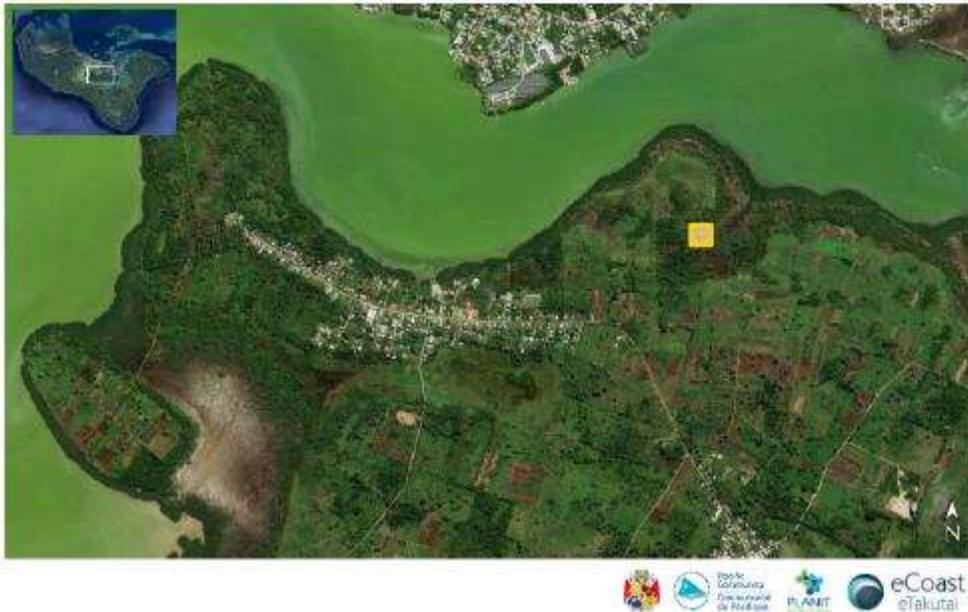
Nukuhetulu and Folaha are losing farmland due to inundation, which is likely being compounded by SLR (Figure 11.9). Local farmers grow cassava, taro, yams, and sweet potatoes, and have also planted pine trees, and are planning more pine tree planting in the near future.

Figure 11.9. Nukuhetulu and Folaha are losing farmland due to inundation, likely being compounded by SLR.

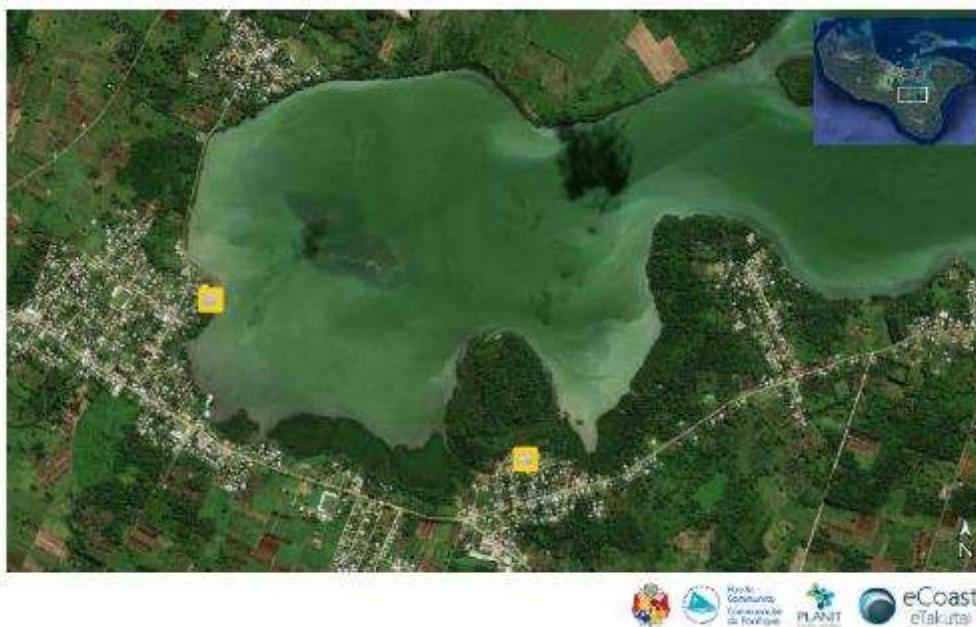
Figure 11.10. At Vaini (left), the road north to Longoteme was 20 m inland a few decades ago, but has been lost to the sea due to removed mangroves. At Malapo (centre), water comes in either side and causes flooding, especially during high tide and northerly winds.

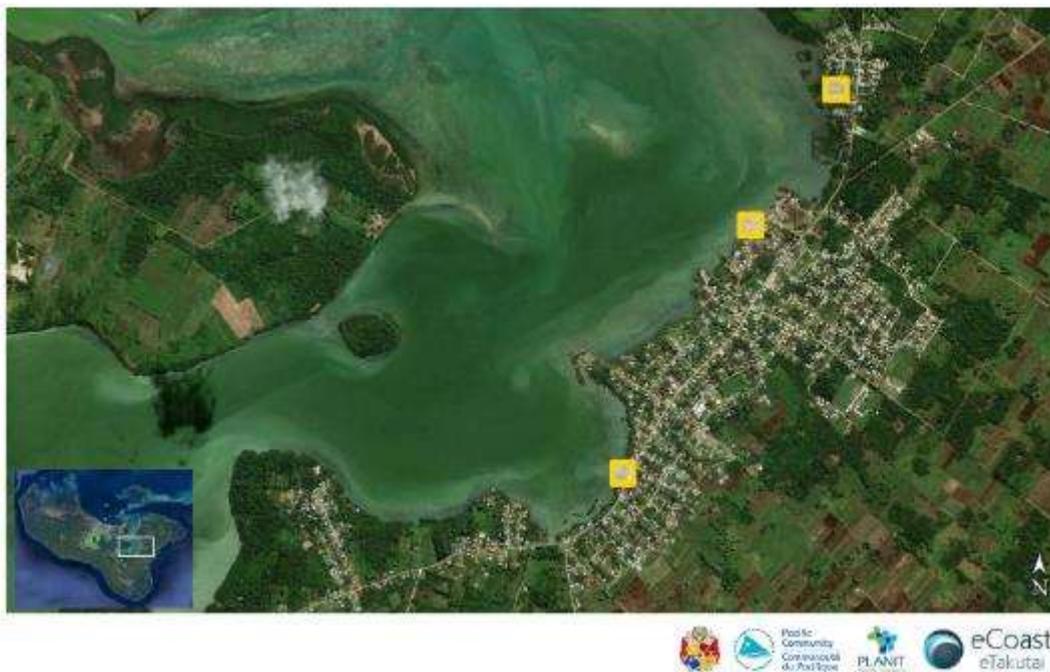
From Alaki to Hoi, inundation occurs along some of the coastal properties (Figure 11.11). Erosion has occurred, and people have lost property along the waterfront (Figure 11.11 middle). The land in this area becomes higher moving inland, although inundation occurs along the waterfront properties at Hoi and Mua.

Figure 11.11. From Alaki to Hoi, inundation occurs along the coastal properties. Erosion has occurred, and people have lost property along the water front (middle).

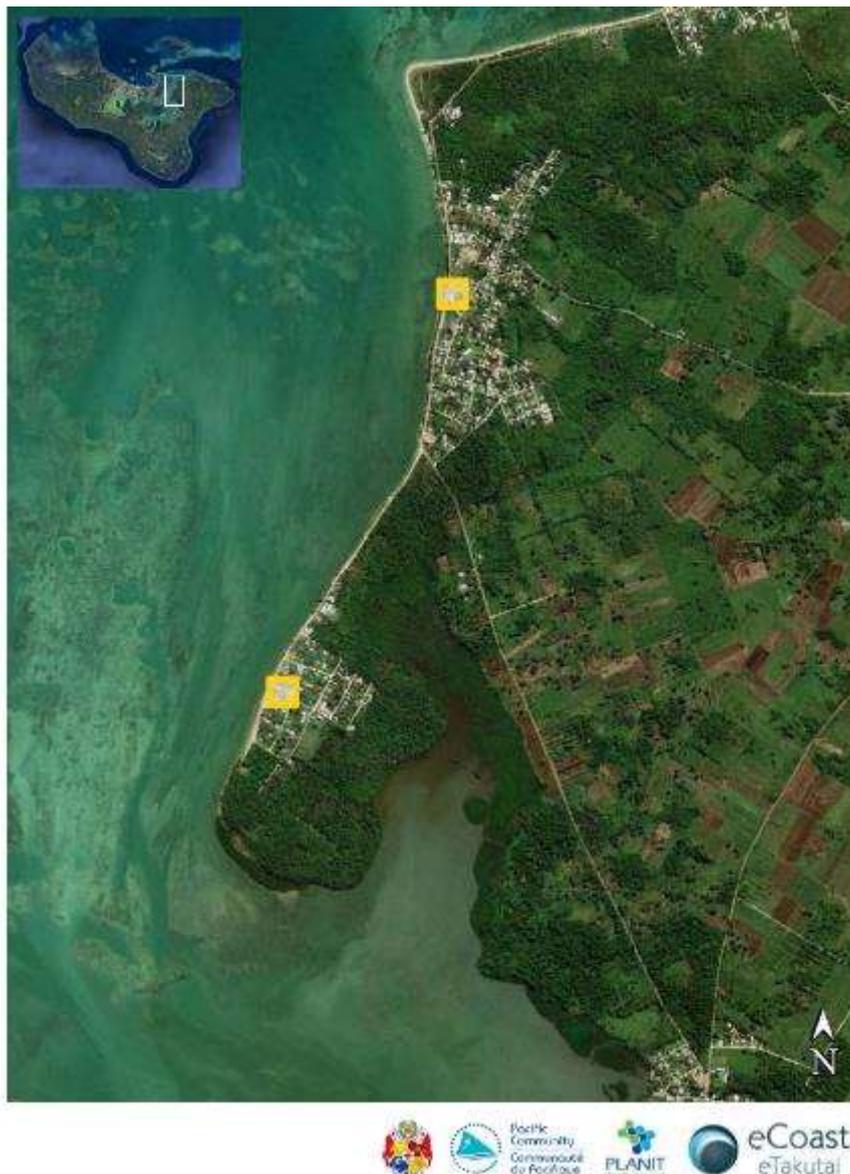
Like Sopu, water comes around both sides of the village at Nukuleka, which has become worst in recent years and is coming up either side of the road at the top of the channel through the mangroves (Figure 11.12). At Talafo'ou and Makaunga, there is some concern that the trial groyne are not working as well as they should. However, sand supply is very limited, and more groyne to fill in the 120 m and 60 m spaces and more sand from the borrow area will result in this stretch of the coast being >10 m wider, as it is where the groyne spacing is 30 m (Mead, 2020).

Figure 11.12. Like Sopu, water comes around both sides at Nukuleka (bottom), which has become worst in recent years and is coming up either side of the road at the top of the channel through the mangroves.

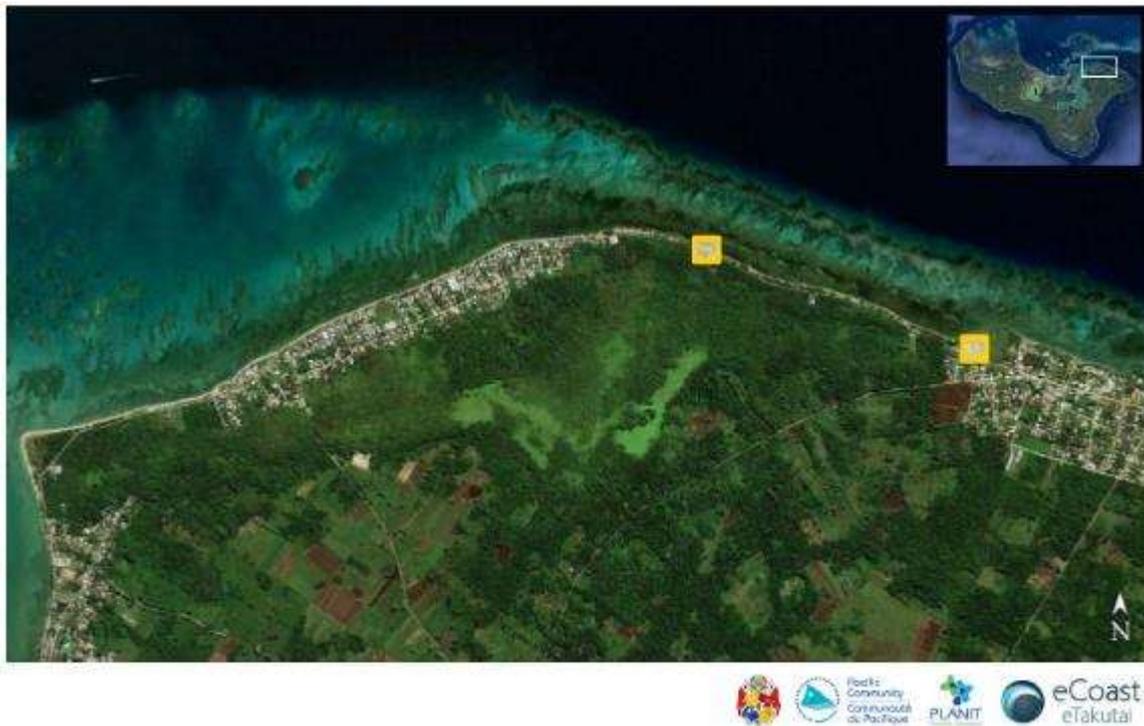
Figure 11.13. The low road between the detached breakwaters at Manuka and Kolonga regularly experiences over-topping and inundation, which was severe during TC Harold.
