GCCA+SUPA - BANABA TRIP REPORT

13th January 2022

Trip Name	Banaba Trip for the Survey of the Existing RO Storage Shed (Formerly known as the Cargo Shed)		
Participants' name including team leader	Teuea Tebau SUPA National Coordinator leading the team Kaiea Collins – MISE structural engineer Auaio Enota – MISE Cost Estimator Tokiiia T – MISE Builder		
Trip sponsor	GCCA+SUPA		
Start date	06/01/2022	End date	10/01/2022
Prepared by	Teuea Tebau (compilation) with specific part contribution from the following: Kaiea on specific engineering parts Auaio and Tokiiia on specific construction and estimating parts

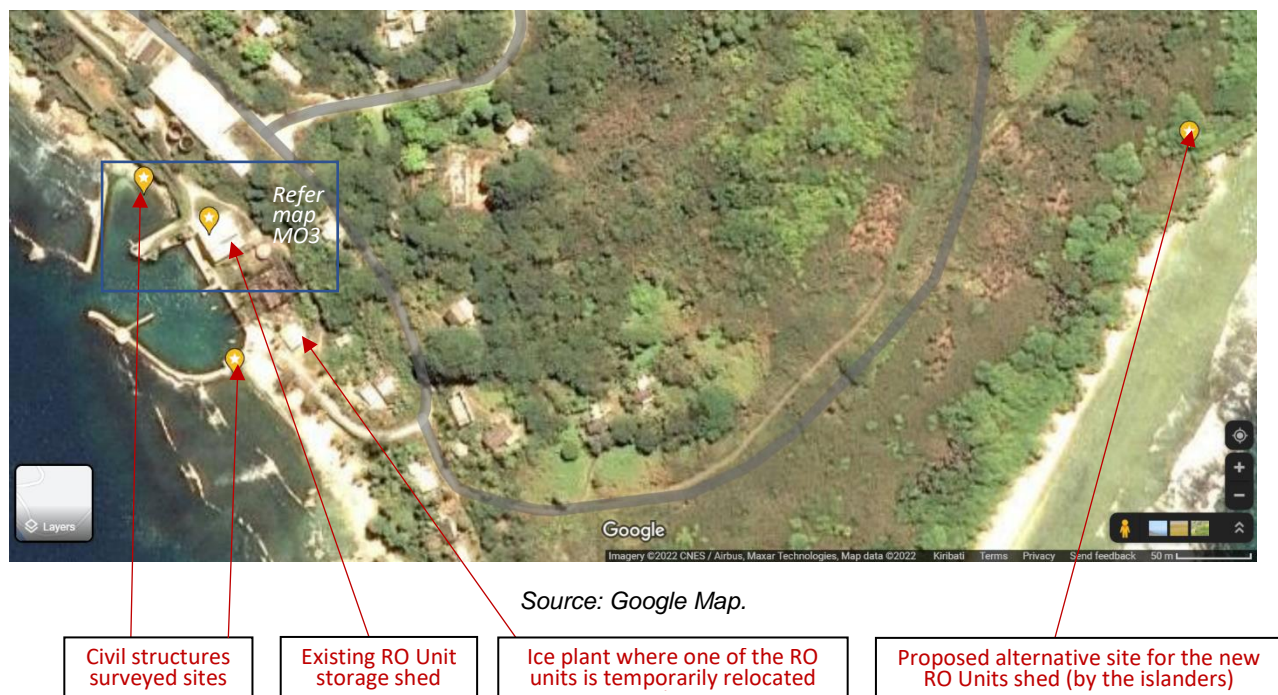
Figure M02 – Map of the Surveyed Sites

these civil works may not be as accurate as if it was done properly and professionally by the civil/coastal engineers.	rectify before it continues to get undermined, or further landslides causing injuries or worst!	work. The specific civil works locations were inspected based on the indication by the locals consulted at the wharf. Refer map for locations at figure MO2.
6	The damaged (chipped) concrete piers are not critical at the time of the inspection.	Professional survey team of civil engineers (etc.) needed to assess and rectify and to get a more accurate measurements for their designs.	Additional findings beside the main scope of survey work. The specific civil works locations were inspected based on the indication by the locals consulted at the wharf. Refer map for locations at figure MO2.

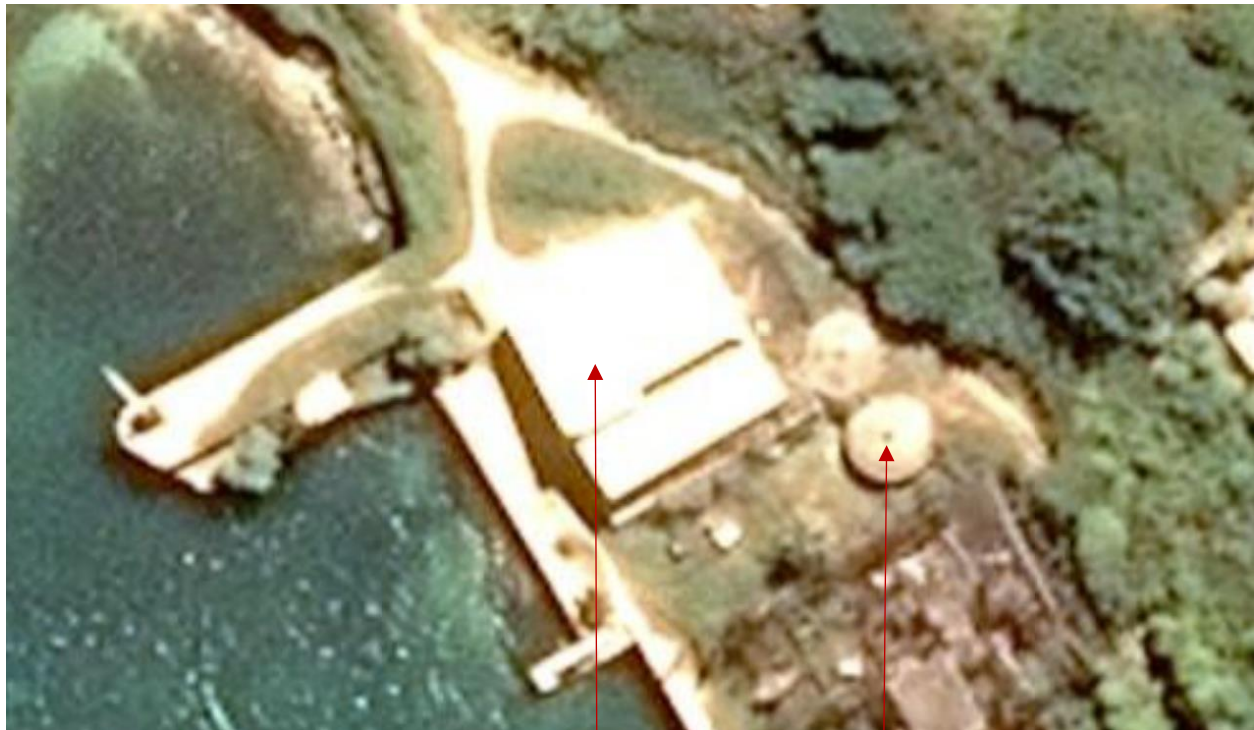
Figure M03 – Map of the Main Surveyed Site

No.	Issue	Solution	Location/site
1	The existing RO shed roof to wall framing structures deemed to be unsafe and require immediate demolition. Except the floor slab as inspected by the engineer and confirmed to be in really good shape and condition and can be retained for future use.	Demolish the roof to wall framing structures. Retain the foundation and floor slab for the new construction to reuse.	Near the harbor slightly toward the north west, on higher ground. Full detailed descriptions in the Engineer's report attached as Annex 1.

Existing RO Unit
storage shed

Concrete water tank
with the collapsed lid

- Cautious dismantling (demolition) of the deteriorated structures to avoid injuries or worst. These include the whole roof structures to the wall framing and rest of supports etc. Also completely remove any steel and rusty metal pieces/remains from the retained concrete slab.
- Retain the existing concrete floor slab for reuse with the new proposed building (RO new storage shed as per the approved design). This analysis is detailed in the engineer's recommendations attached with this report.
- Immediate action to the critical civil infrastructure works
- Follow the suggestions of the builder to amend the design to raise the floor slabs by one course (new building only refer to the sketch layout at Annex 3).
- Adjust the design, costing, workplan and other necessary building construction documents based on the findings onsite.

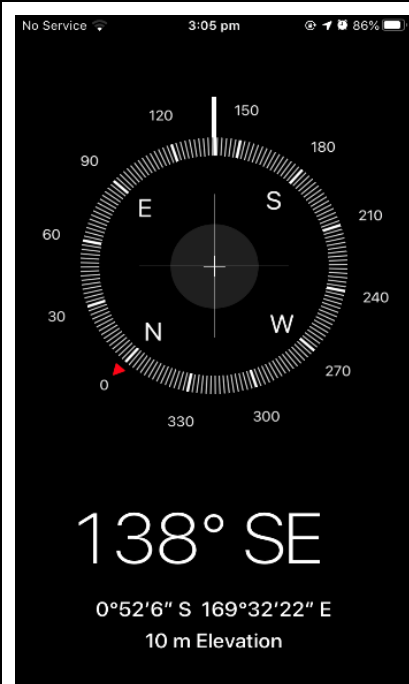
Fig A14 – coordinate location of the collapsed seawall.

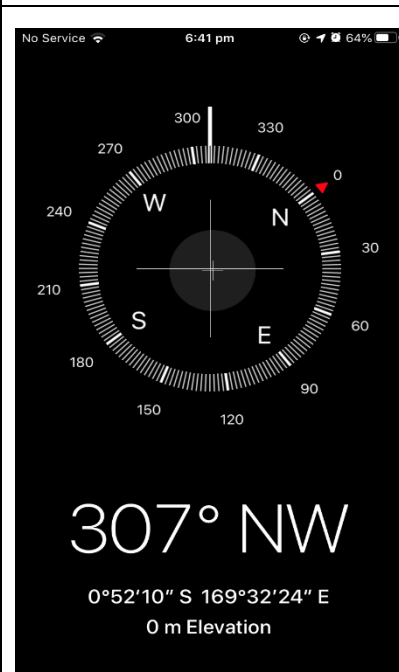
Fig A17 – approx. coordinate location of the damaged jetty structures.
